Confidential Property Report

A.C.C.S. PROPERTY INSPECTIONS

Information Centre – Mission Beach

14/05/2024 and 12/6/2026

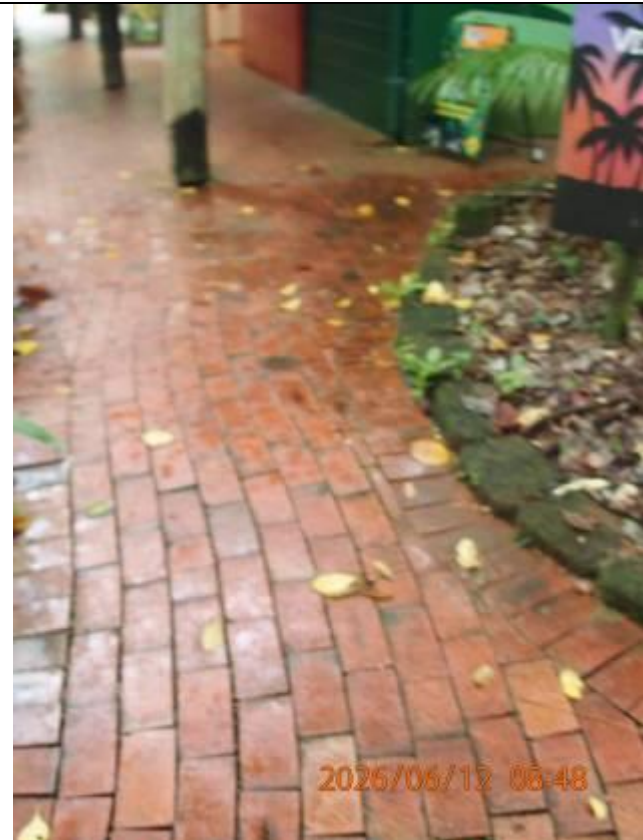
Paving / Tiling

- Defect: uneven surface and mould
- Location: as pictured
- Recommendation: cleaning required

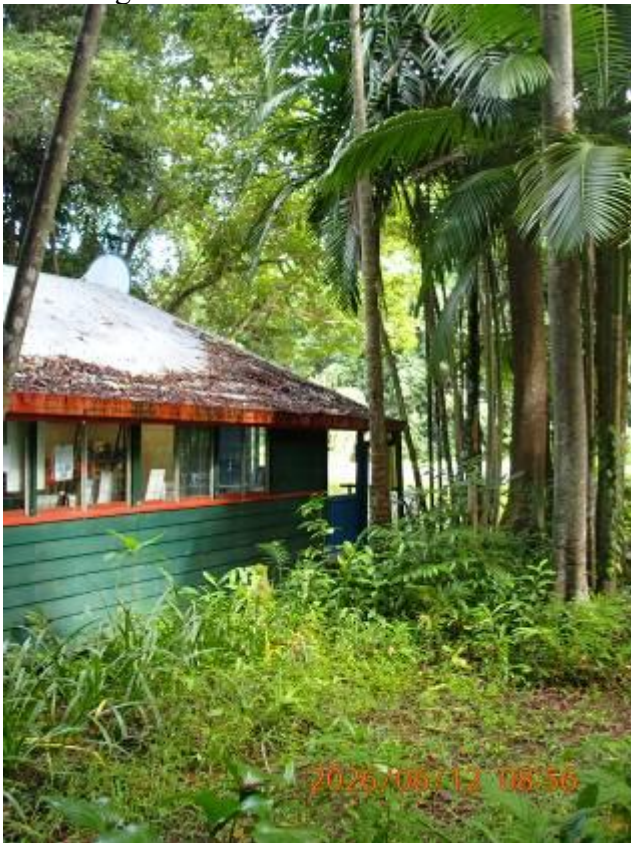
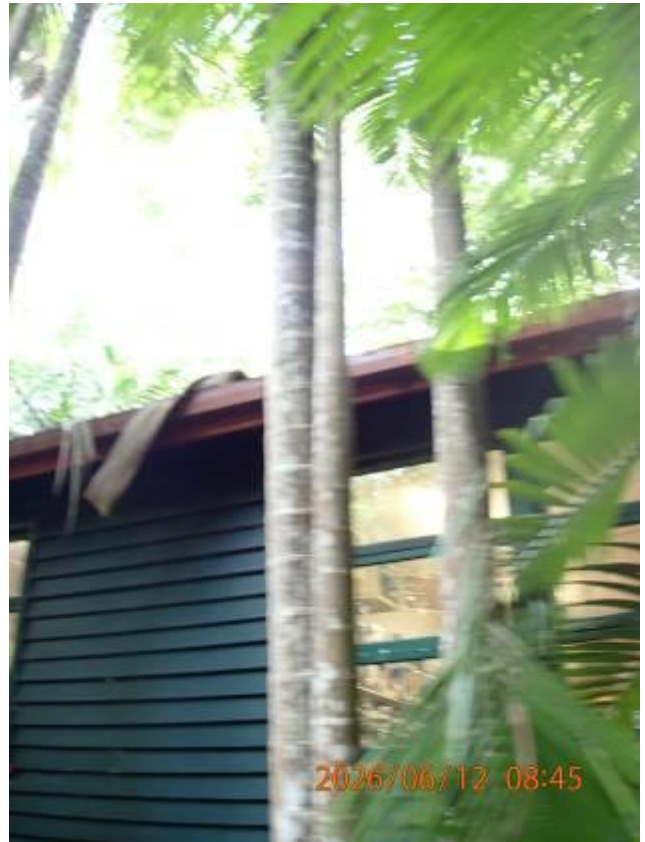
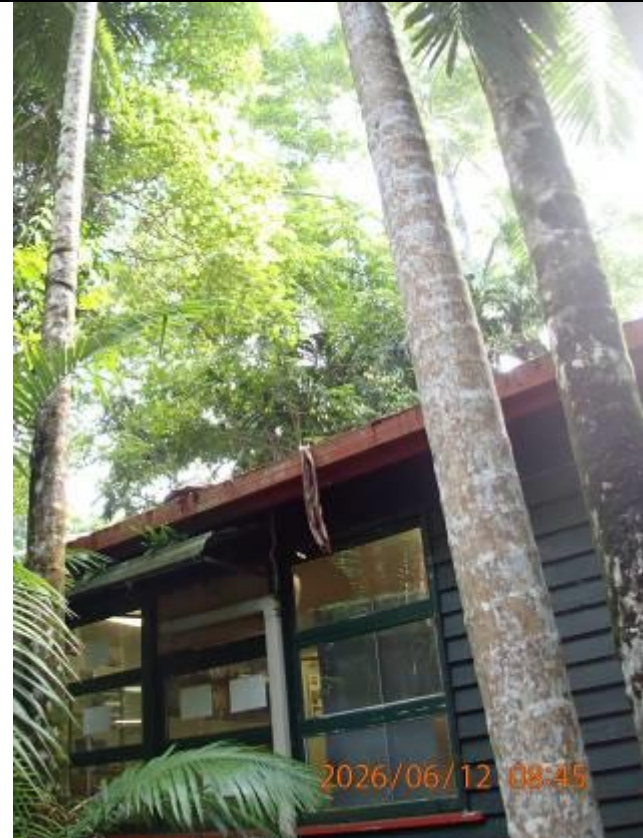
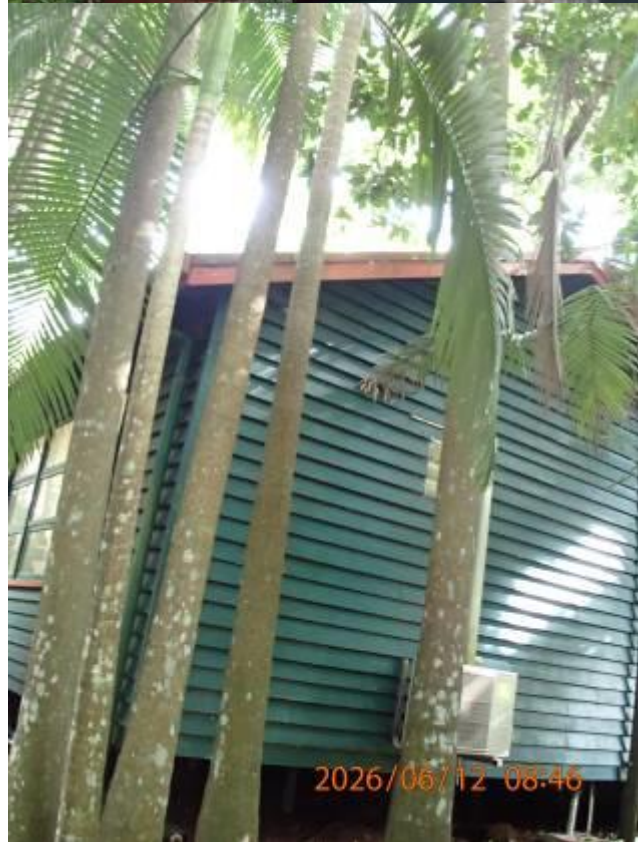
Trees & garden beds

- Trimming to all trees recommended
- removal of trees which overhang roofing is recommended.

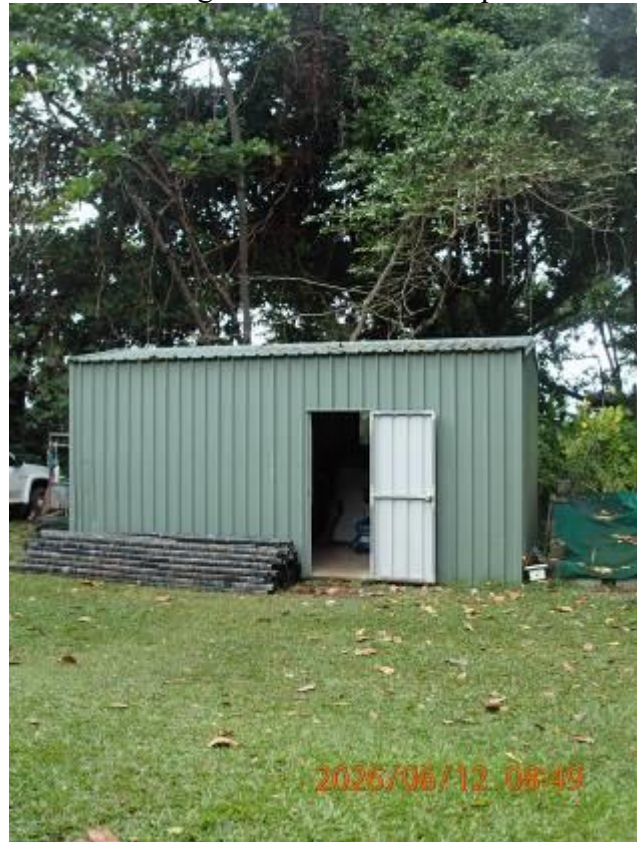
Shed

- cleaning of roof and walls required.

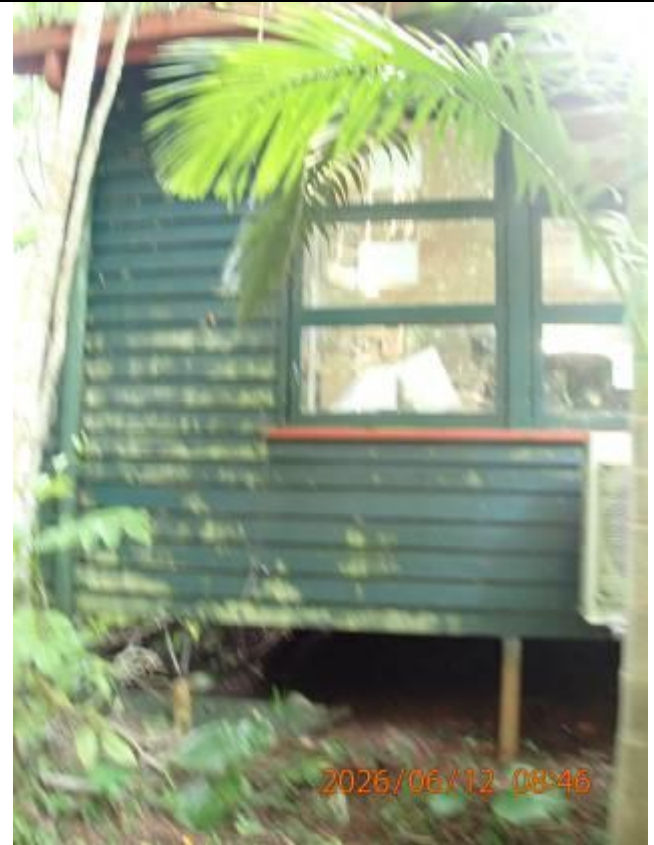
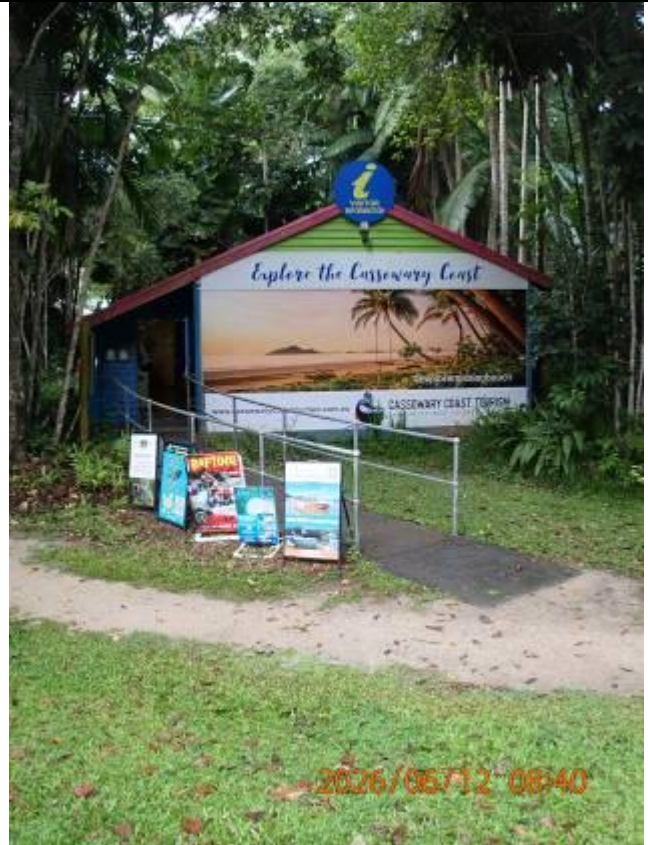
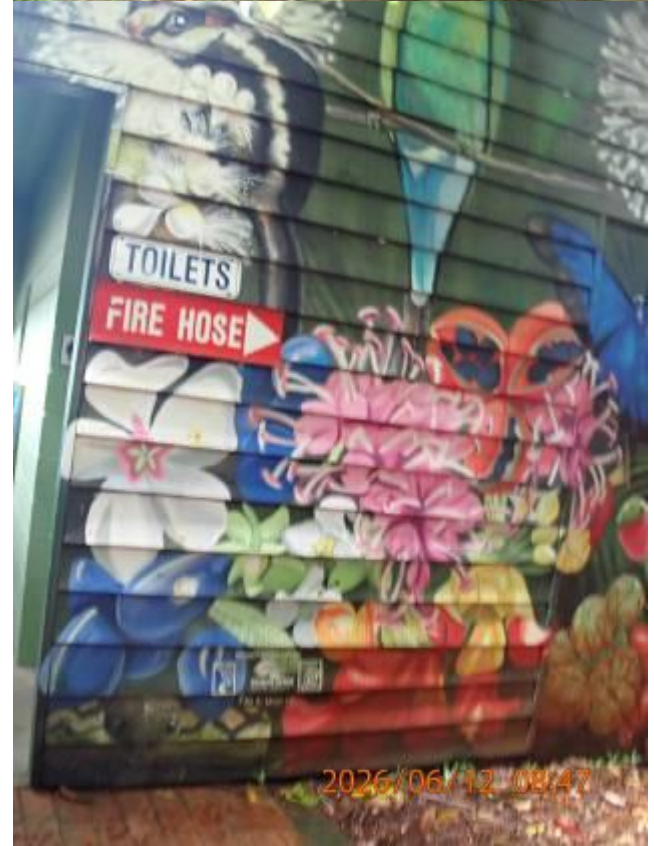
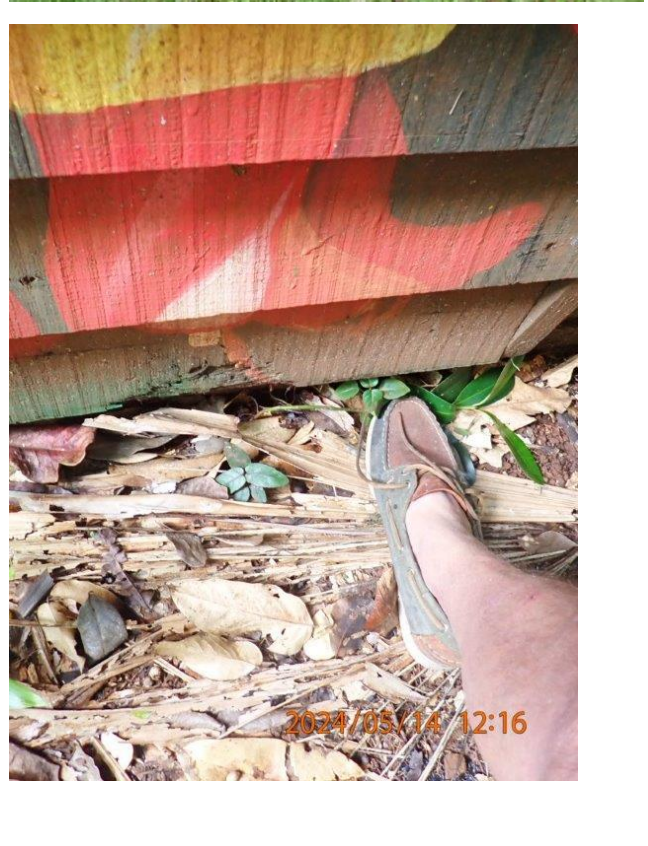
Building/House Exterior	Comments
External Walls and claddings	<ul style="list-style-type: none">• Defect: Timber rot present• Location: as pictured• Recommendation: Major remedial action required

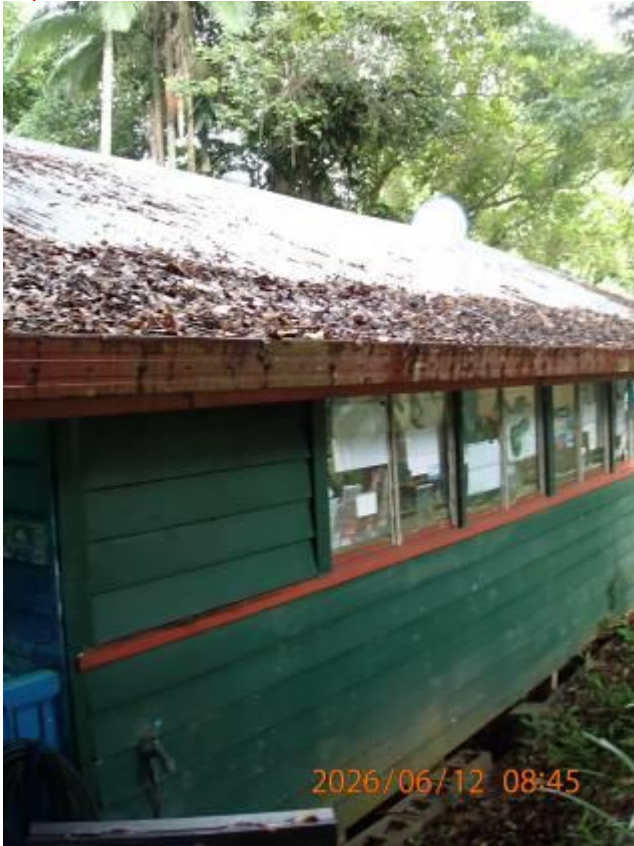
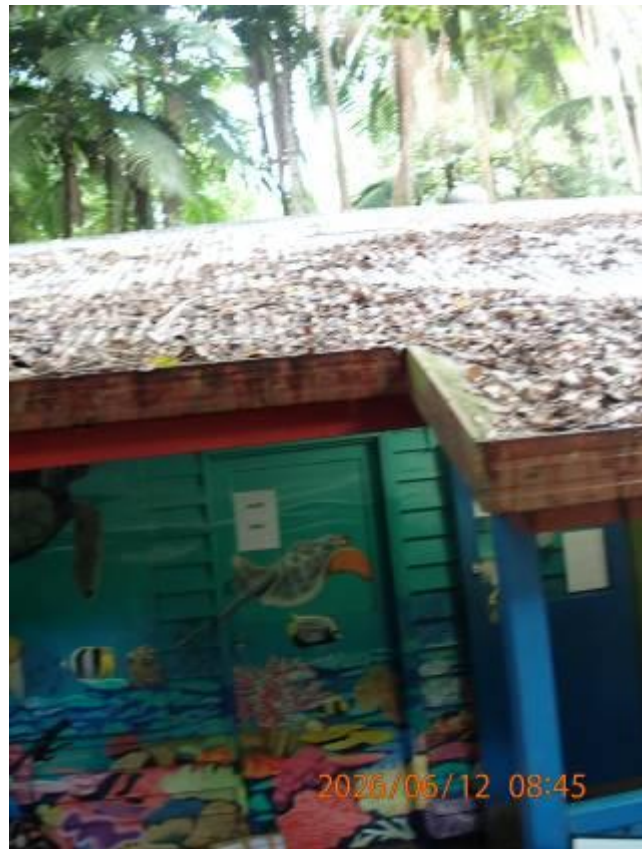
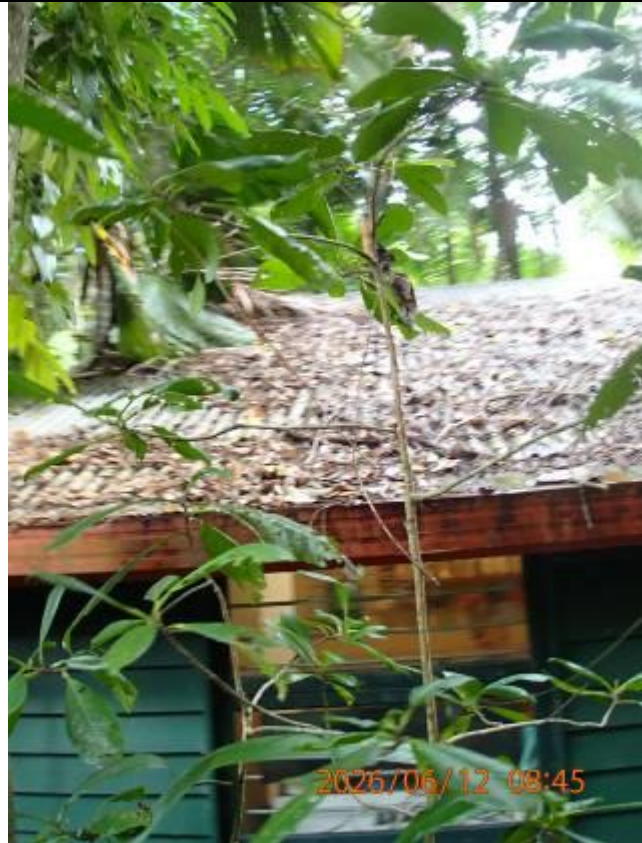
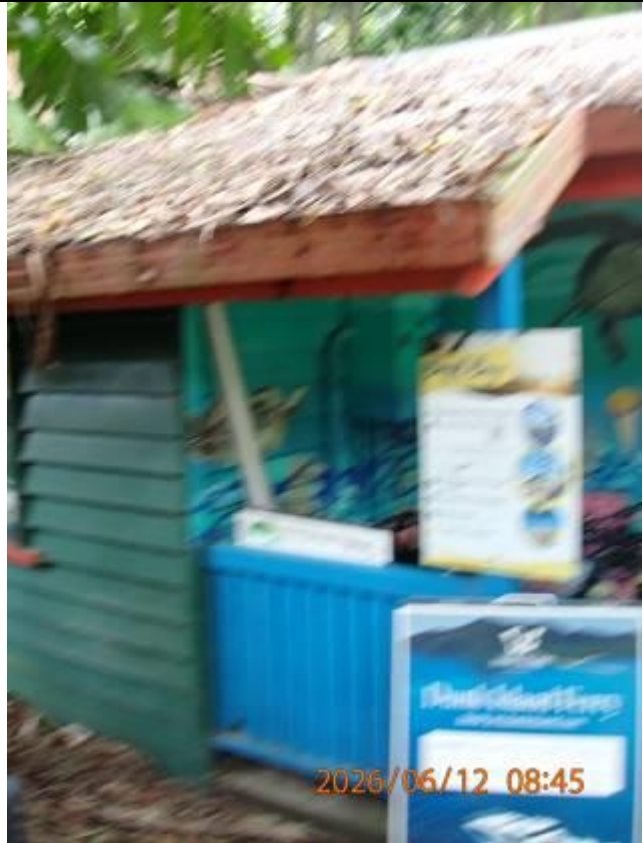
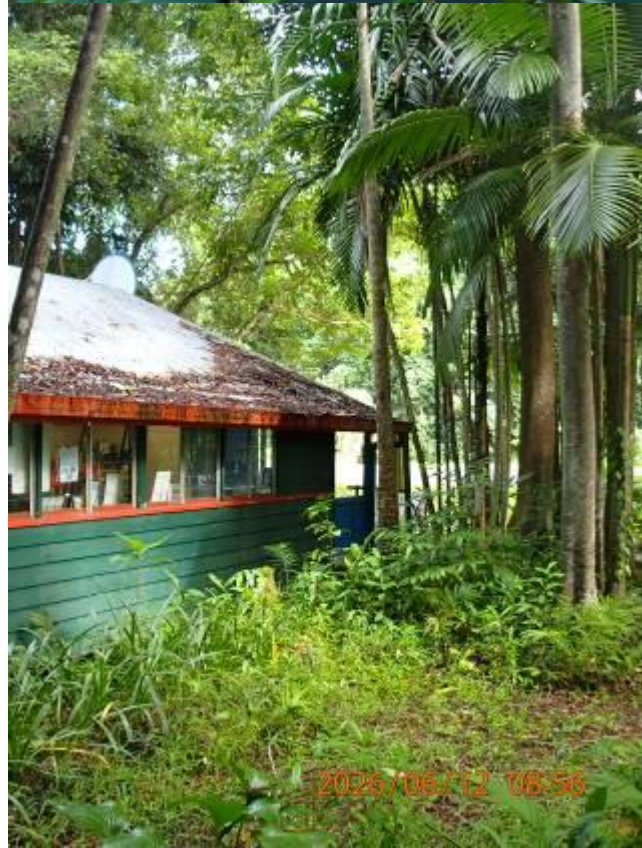
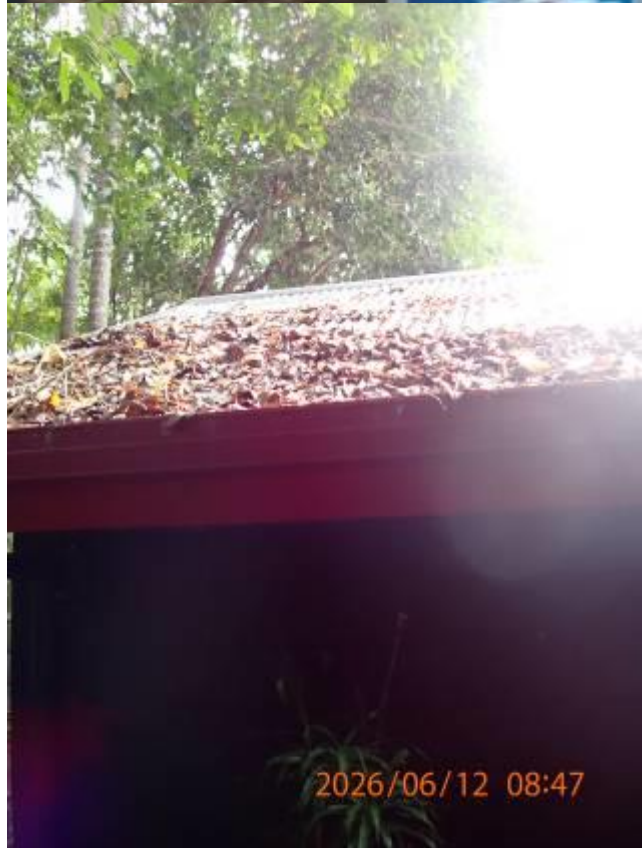
- Defect: Deterioration visible to all surfaces and fixings
- Location: throughout
- Recommendation: **Plumber** – Engage a suitably qualified plumber to provide rectification advice in accordance with AS/NZ 3500

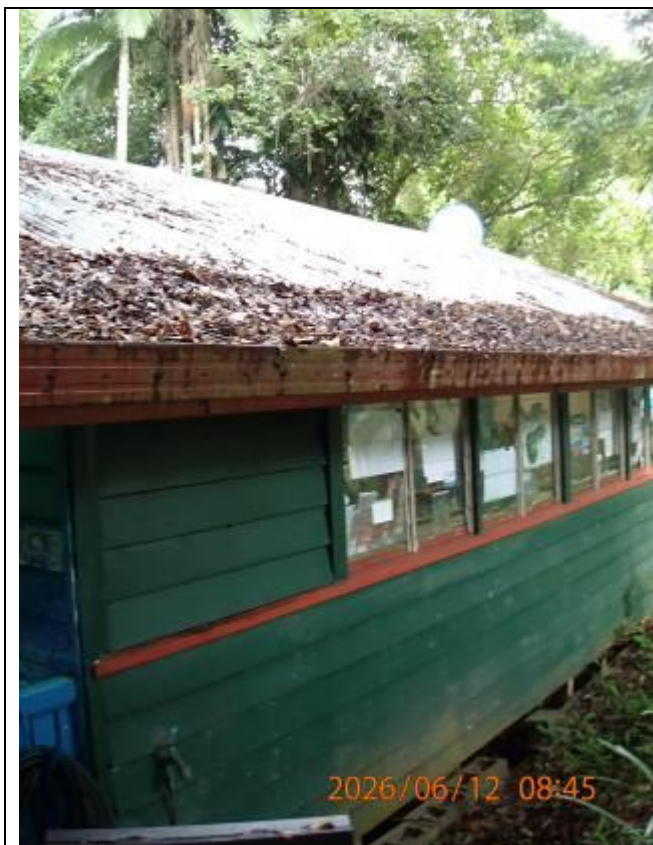
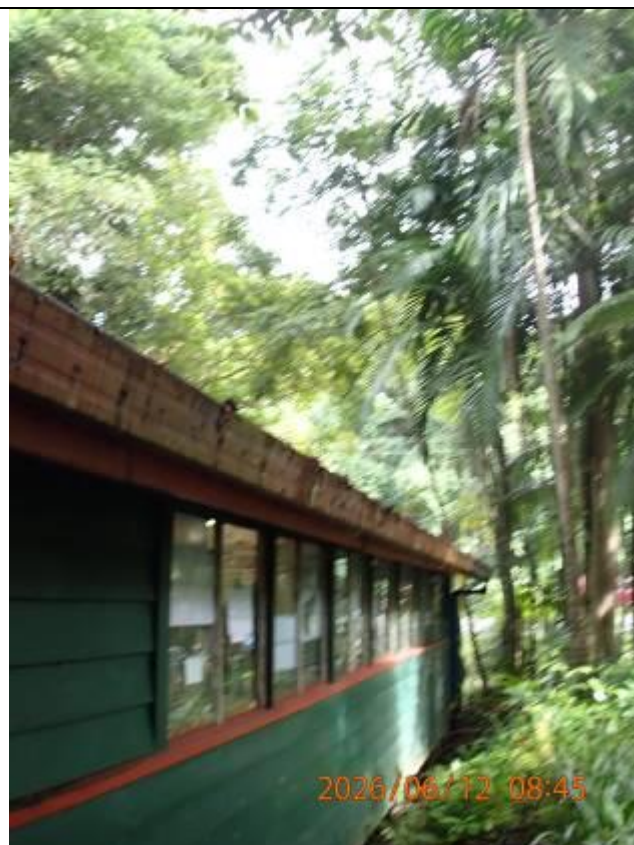
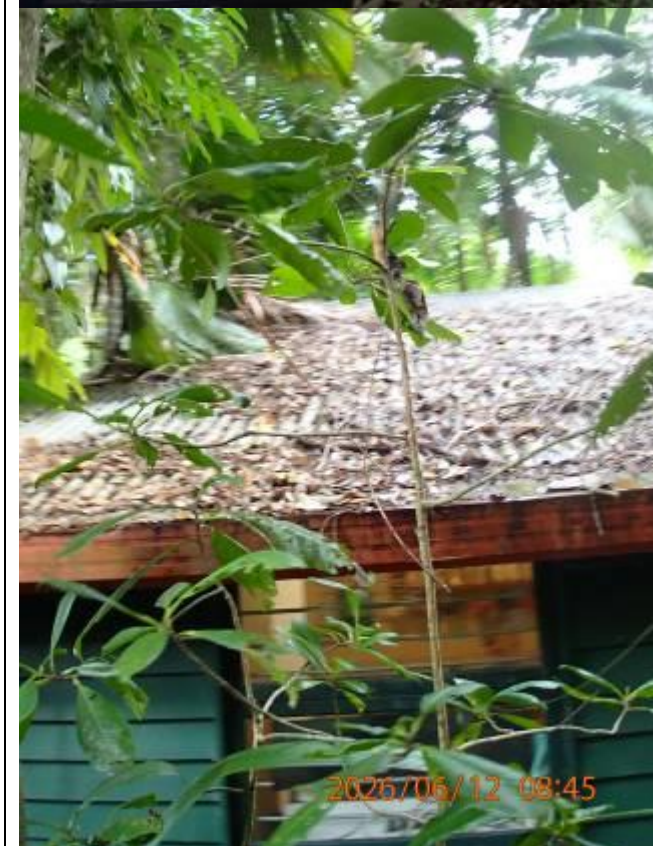
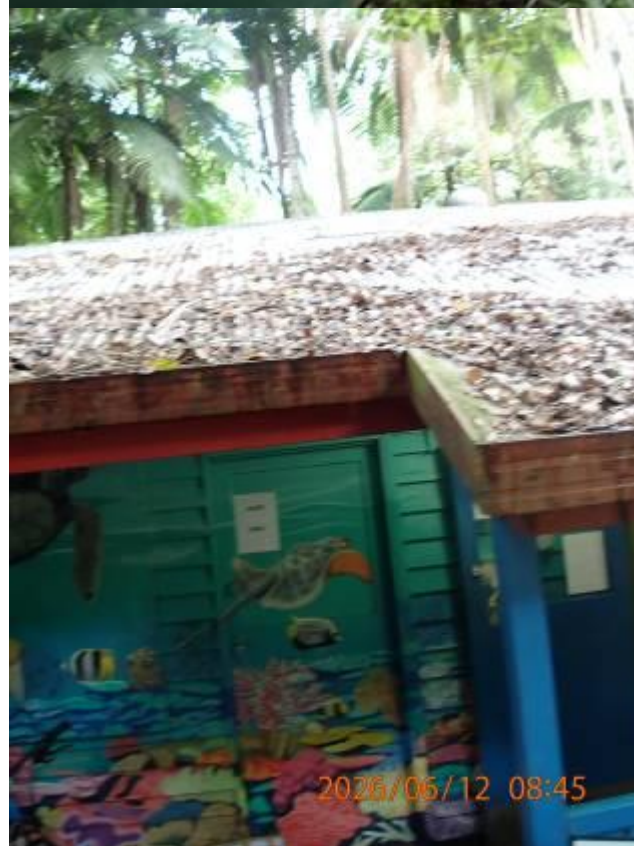
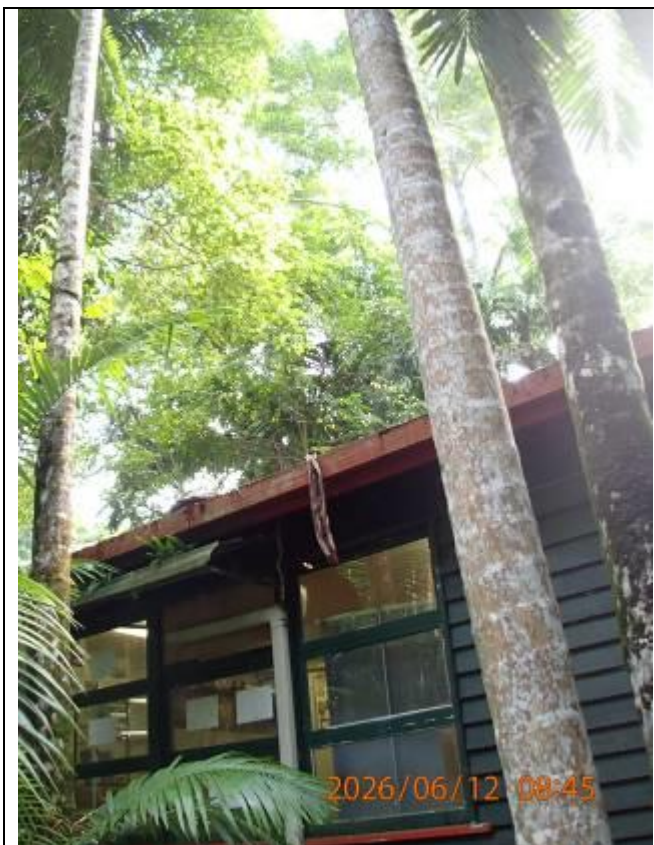
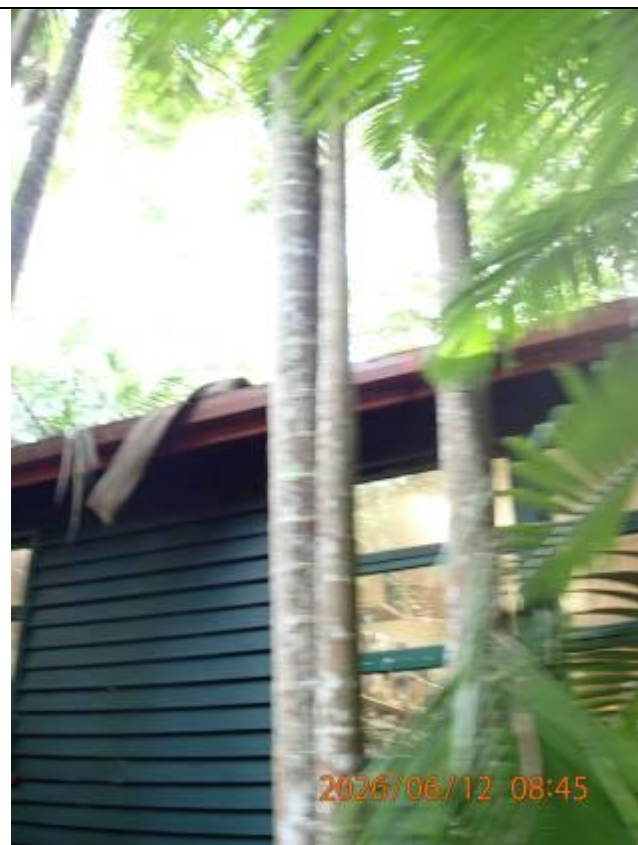
- Defect: Deterioration visible to all surfaces and fixings
- Location: throughout
- Recommendation: **Plumber** – Engage a suitably qualified plumber to provide rectification advice in accordance with AS/NZ 3500

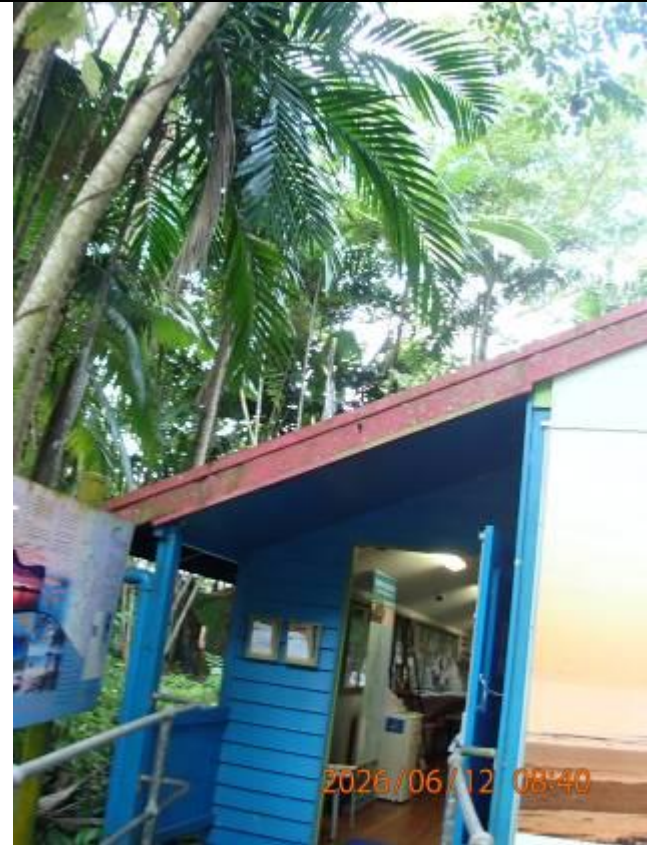
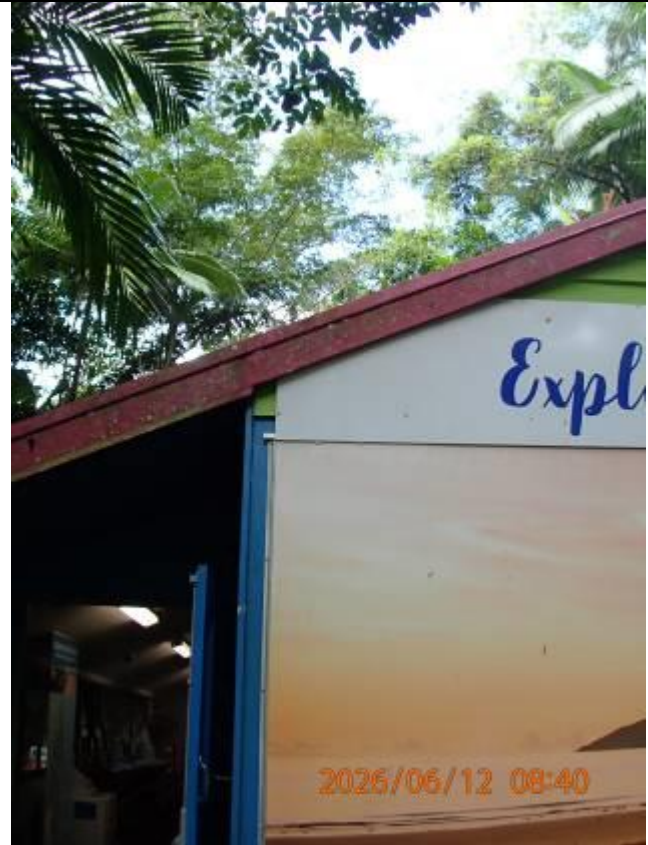
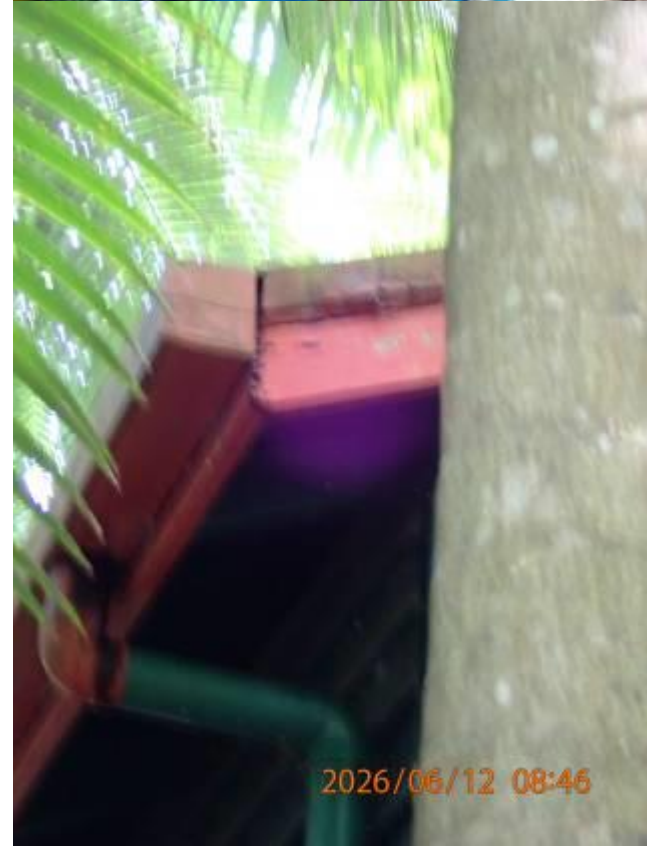
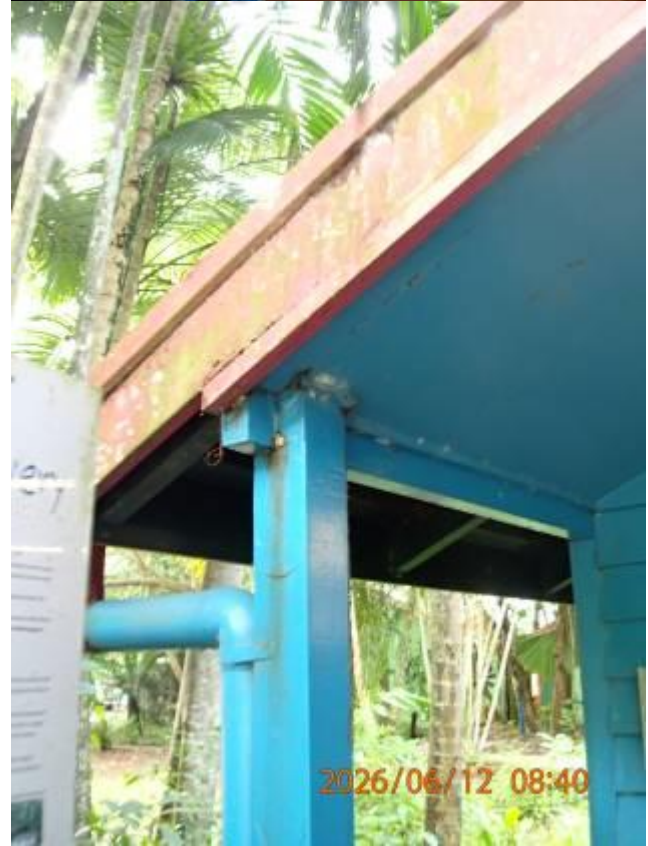
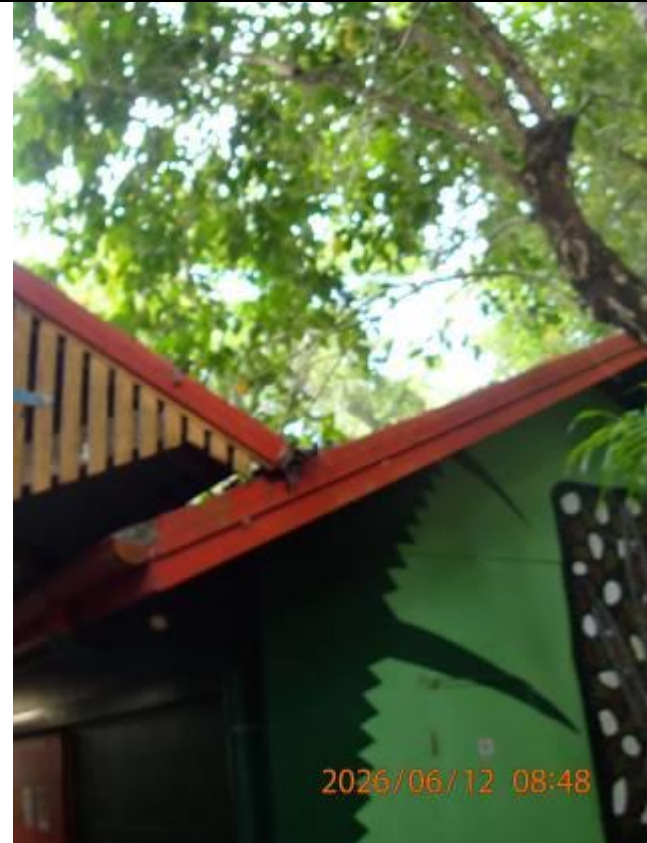
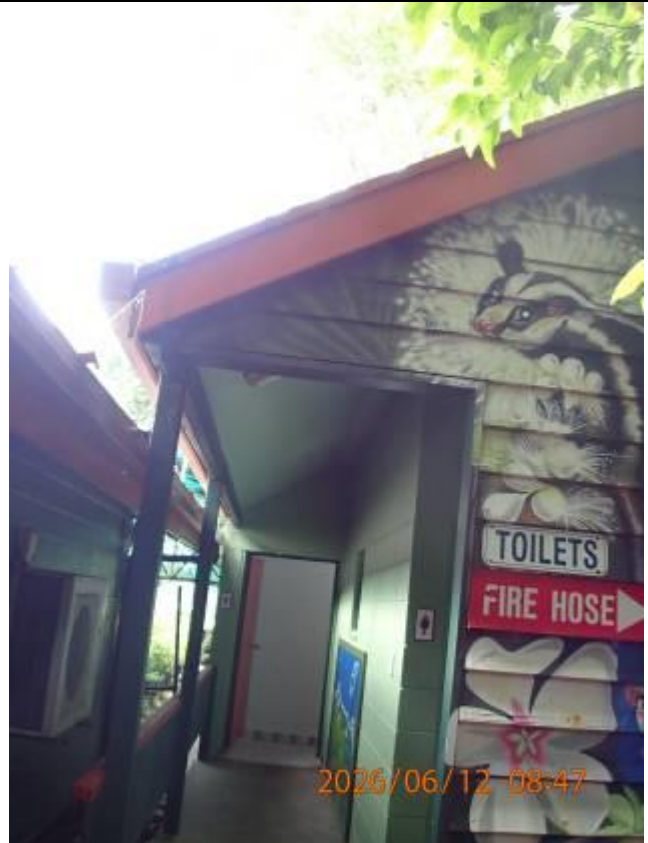
- Defect: movement of all sheeting is visible.
- Roof space is accessible to rodents.
- Recommendation: **Plumber** – Engage a suitably qualified plumber to provide rectification advice in accordance with AS/NZ 3500

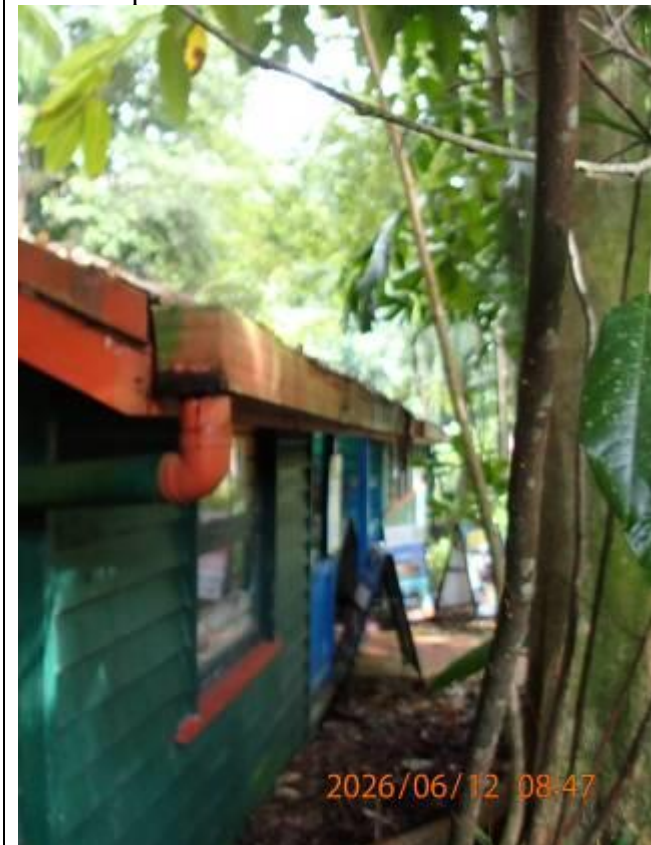
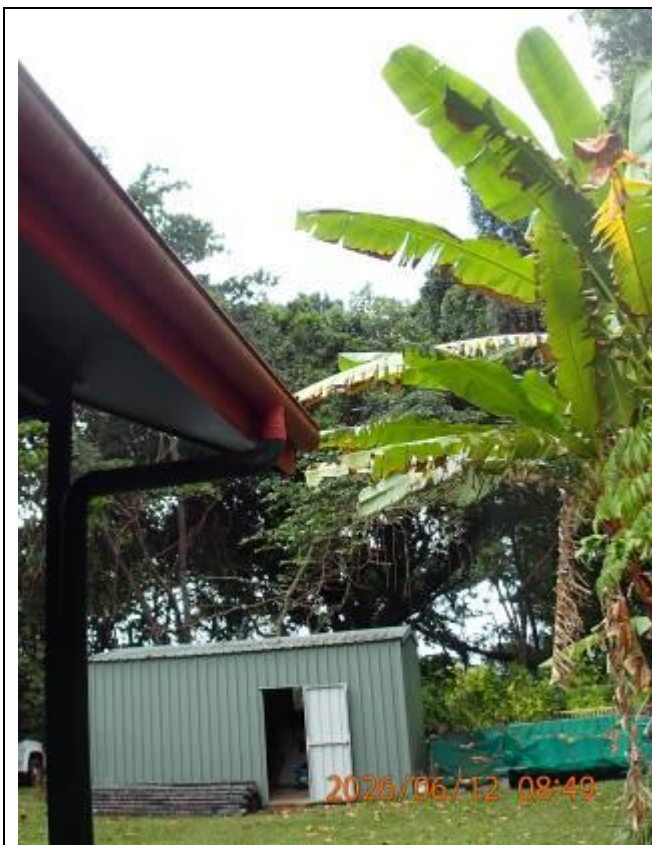
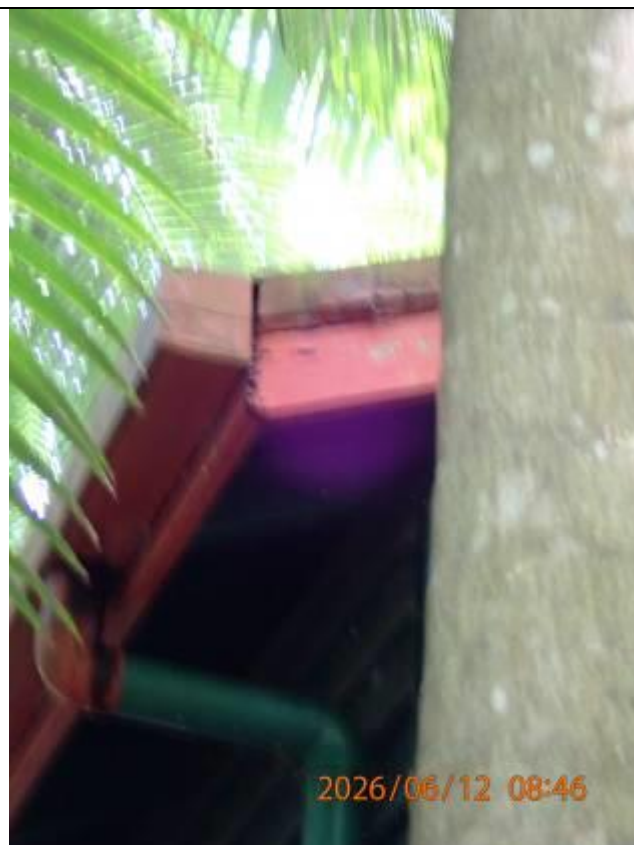
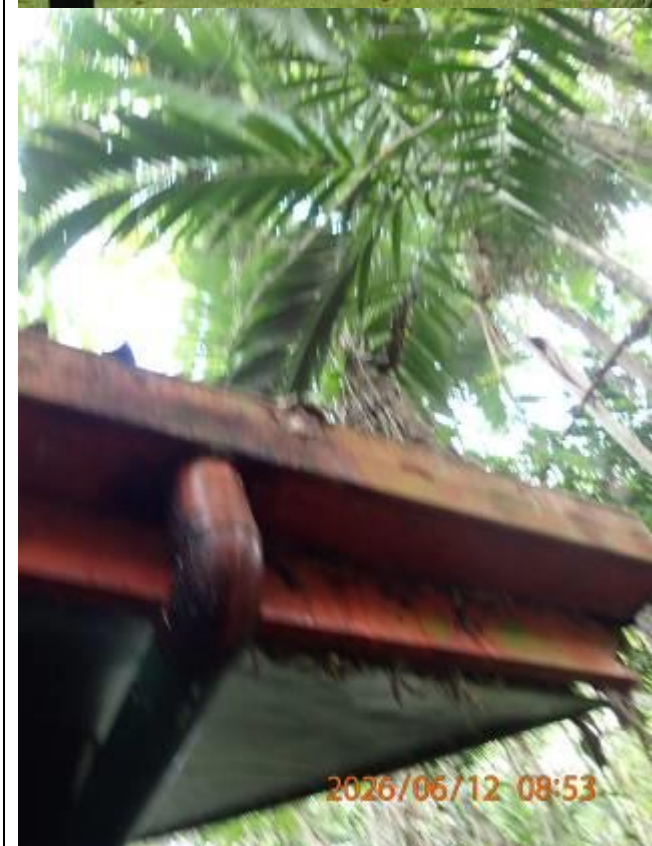
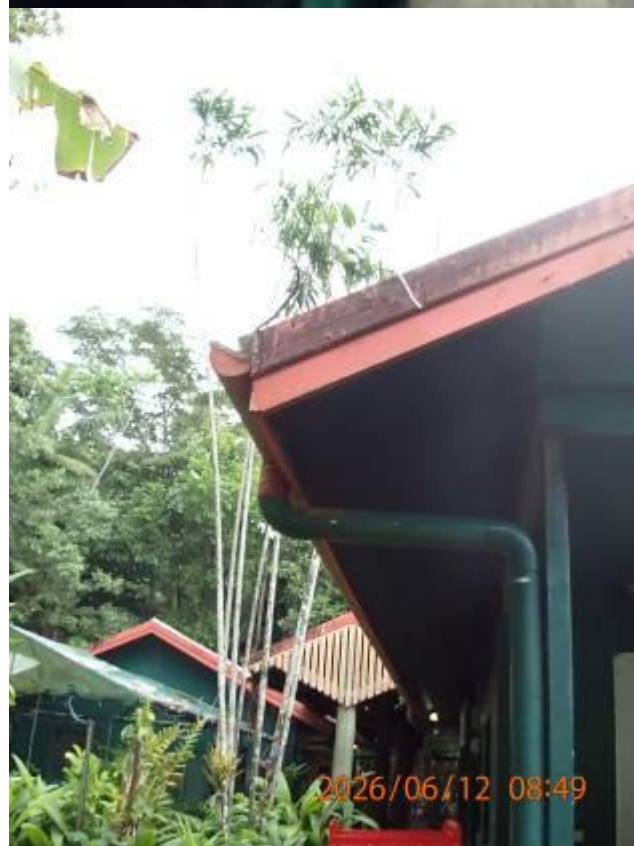
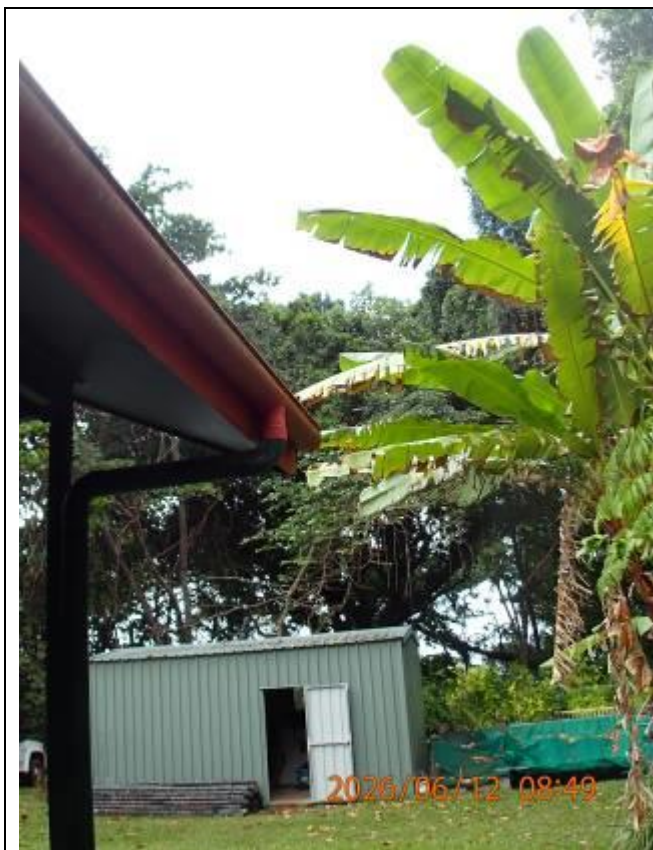
Down Pipes

- Defect: Mould and deterioration present
- Location: throughout
- Recommendation: **Plumber** – Engage a suitably qualified plumber to provide rectification advice in accordance with AS/NZ 3500

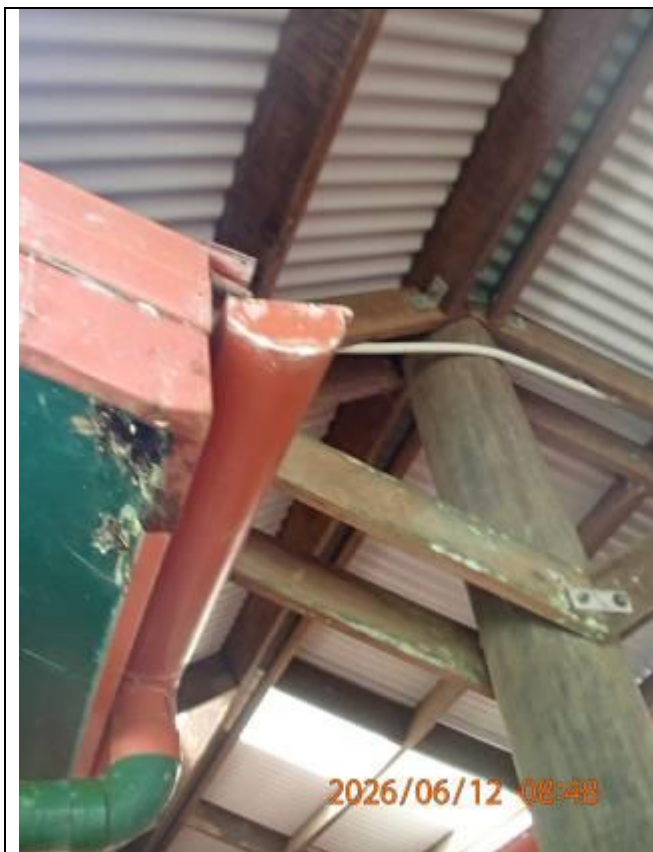
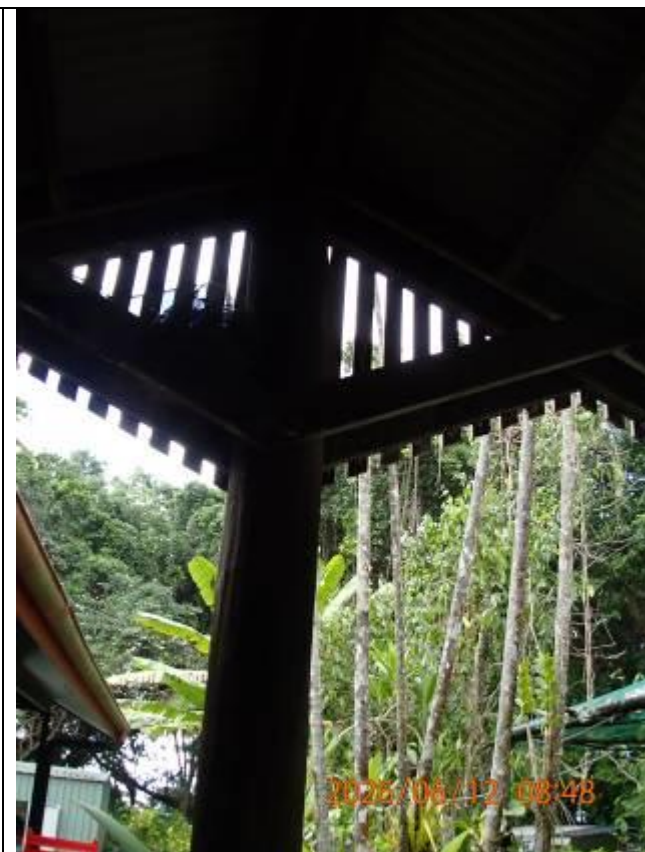
- Visible rust to base of several metal supports, repairs are required. Deterioration to timber supports.

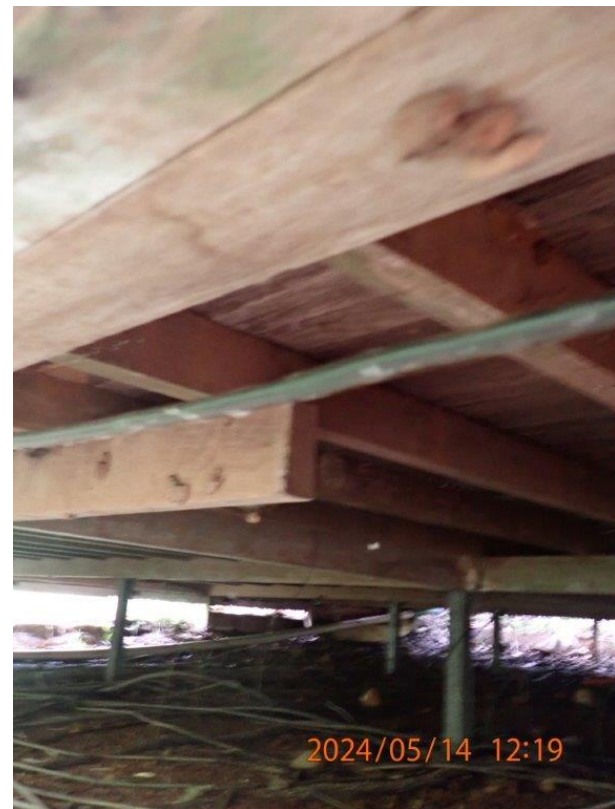
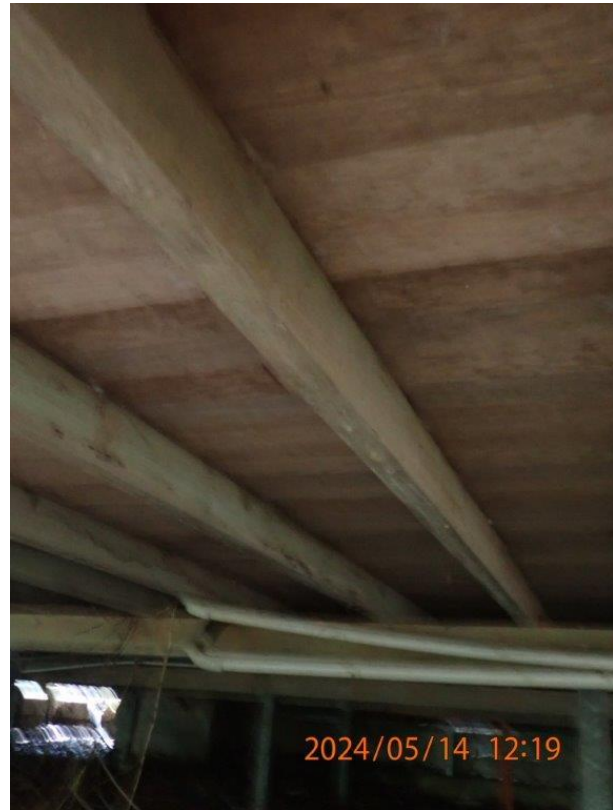
Bearers and Joists

• Defect mould

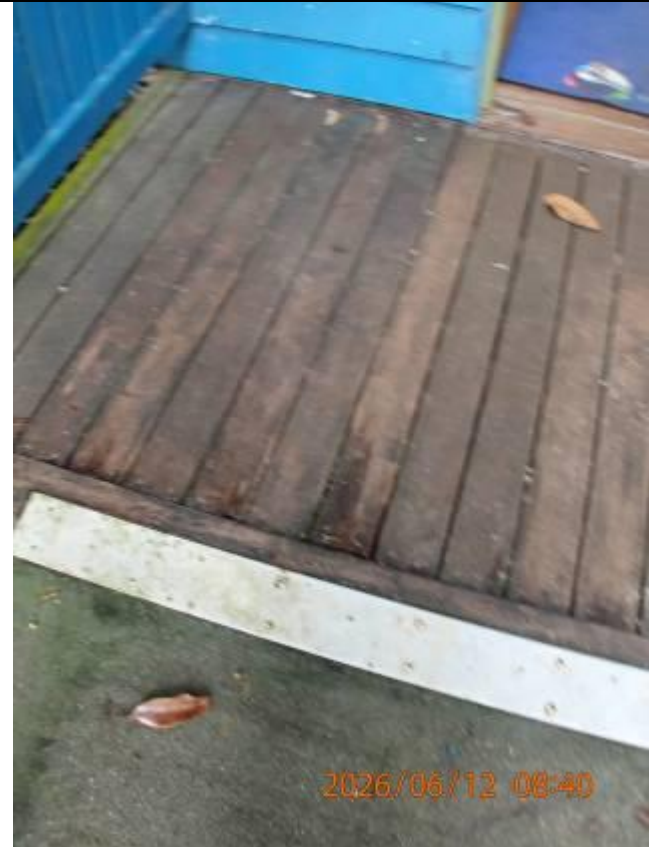
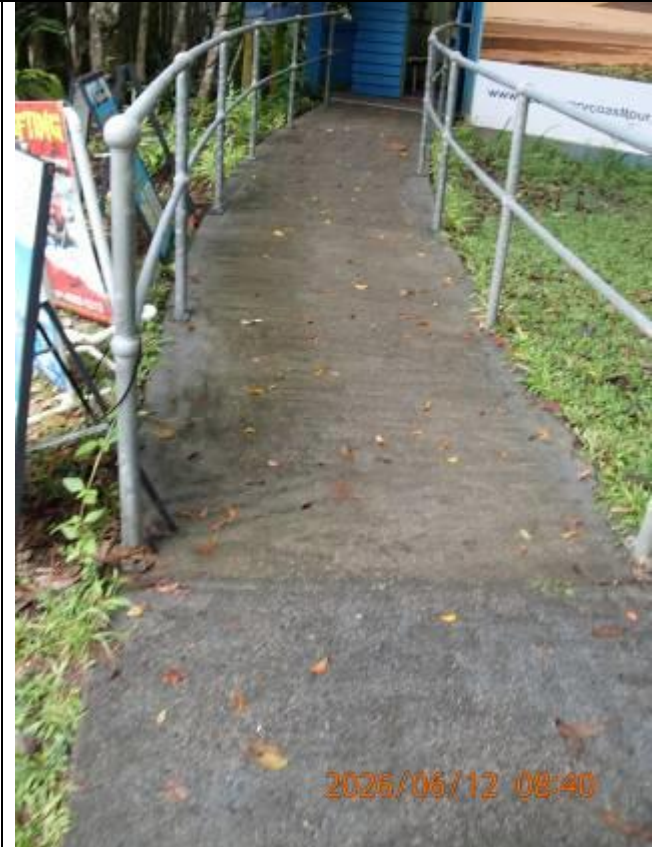
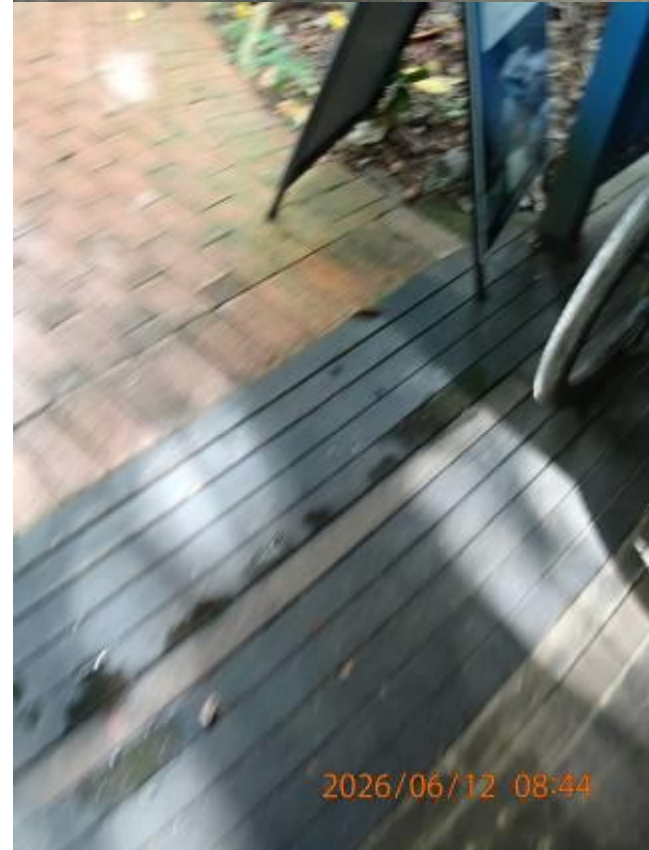
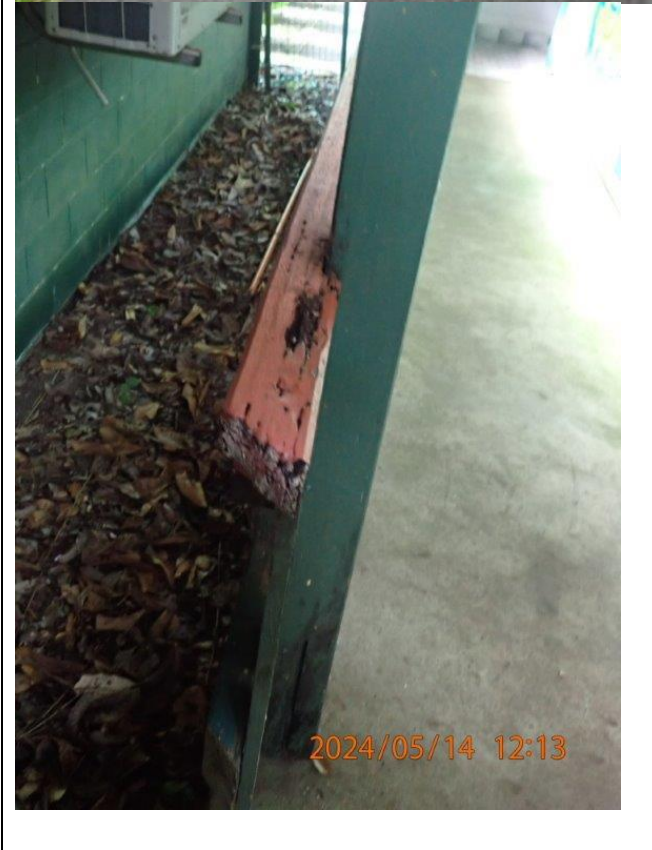
Stairs and verandah

- Timber rot present.
- timber deterioration visible to supports, balustrades, etc
