Confidential Property Report

A.C.C.S. PROPERTY INSPECTIONS

Information Centre – Mission Beach

14/05/2024 and 12/6/2026

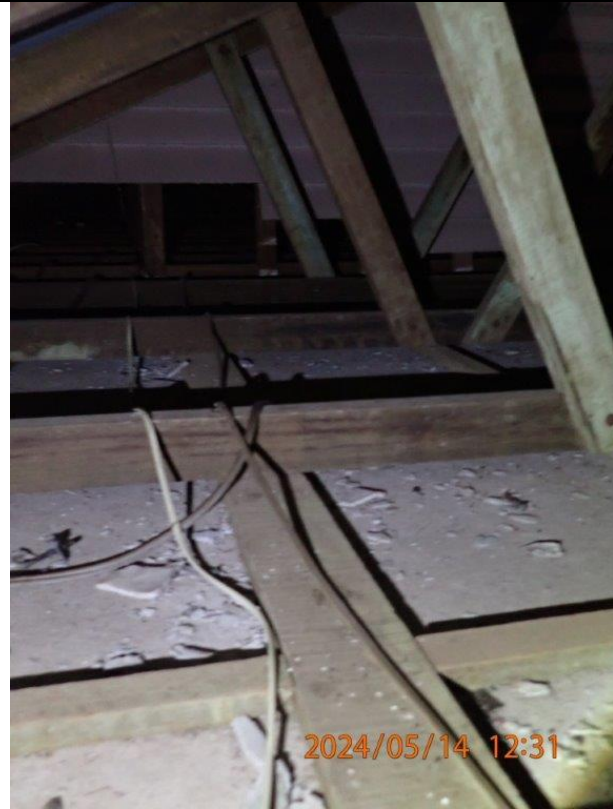
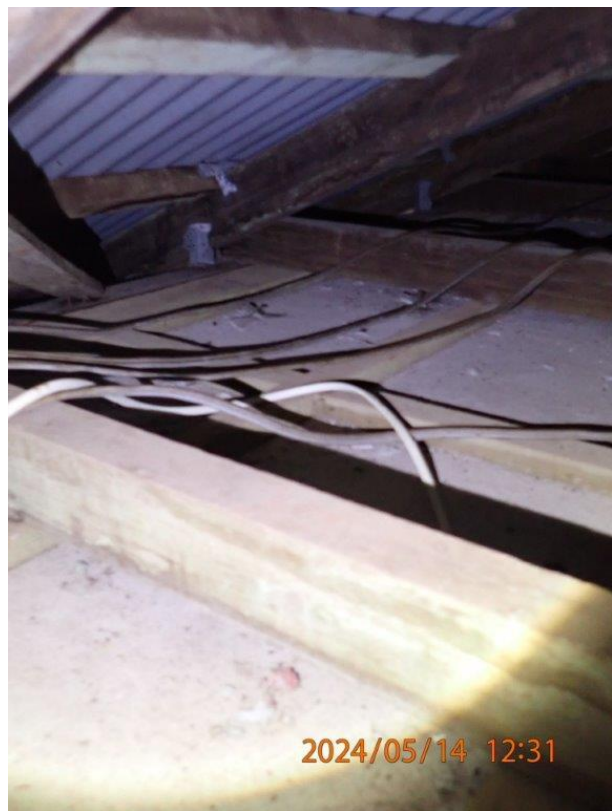
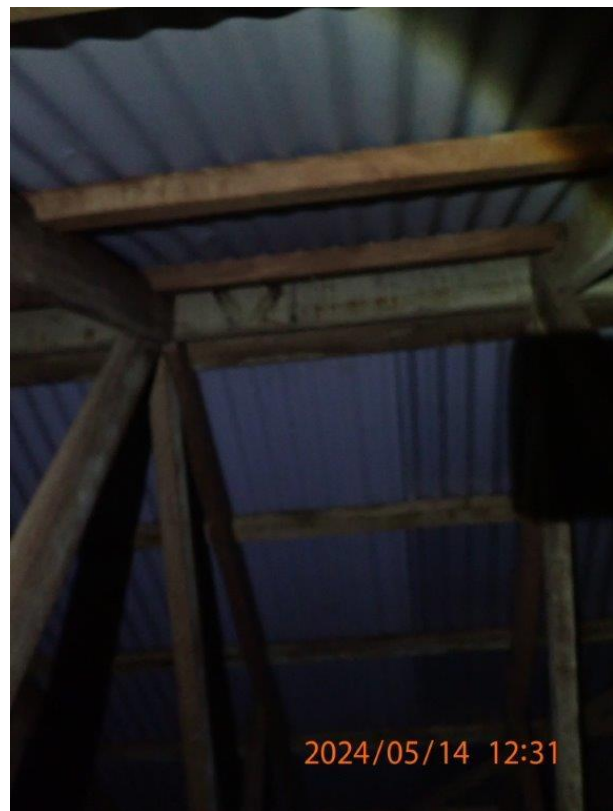
<ul style="list-style-type: none"> • Defect: minor deterioration • Recommendation: Carpenter – engage a suitably qualified carpenter for rectification advice in accordance with A1684.2

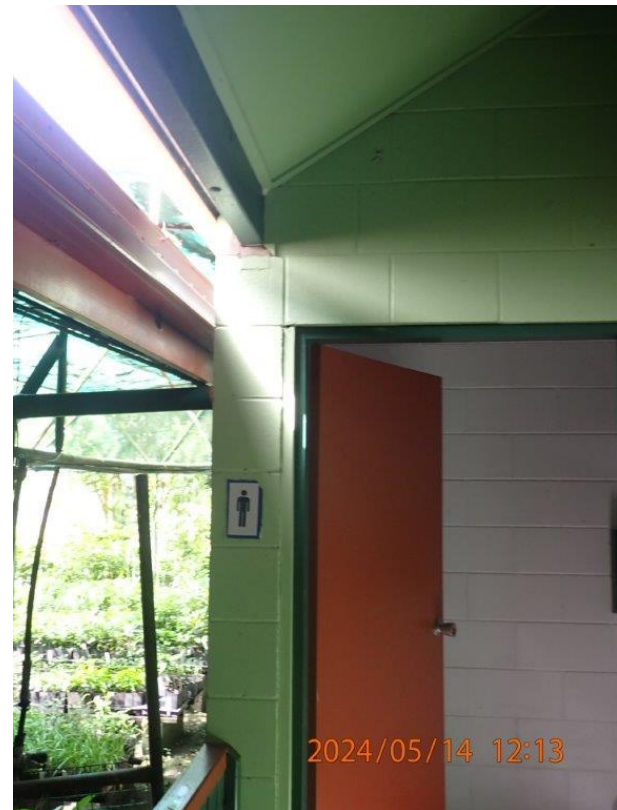
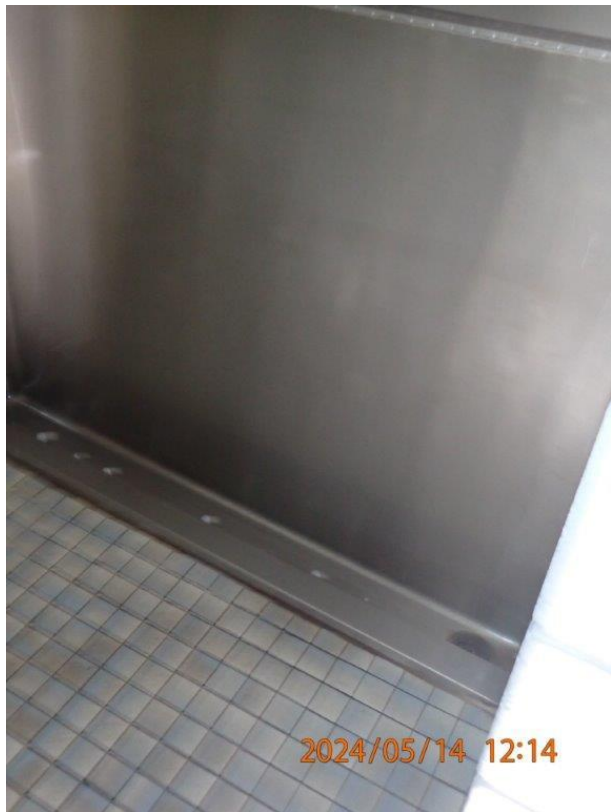
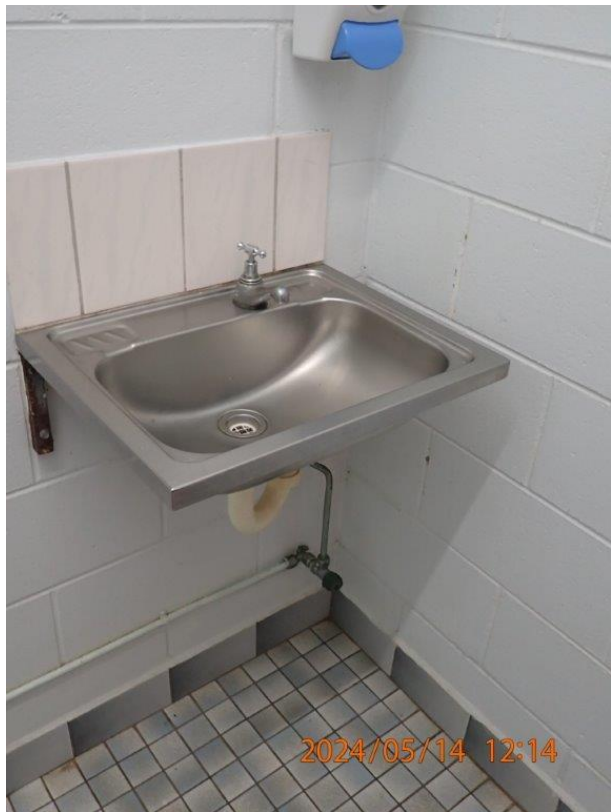
Bathroom 2 –

- Deterioration to doors
- Generally, appears to be in an acceptable condition.
- Recommend replacement of all sealants as preventative maintenance when required.

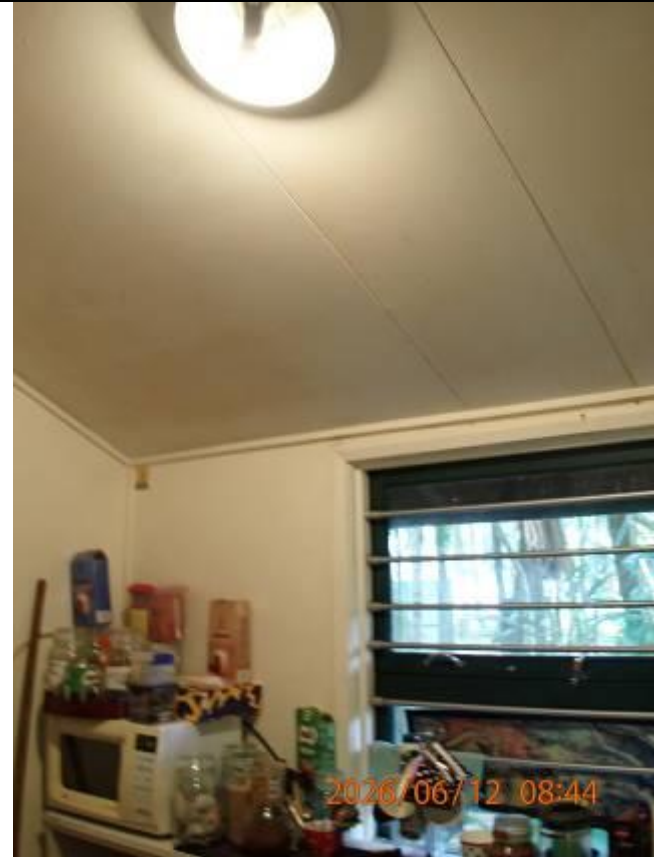
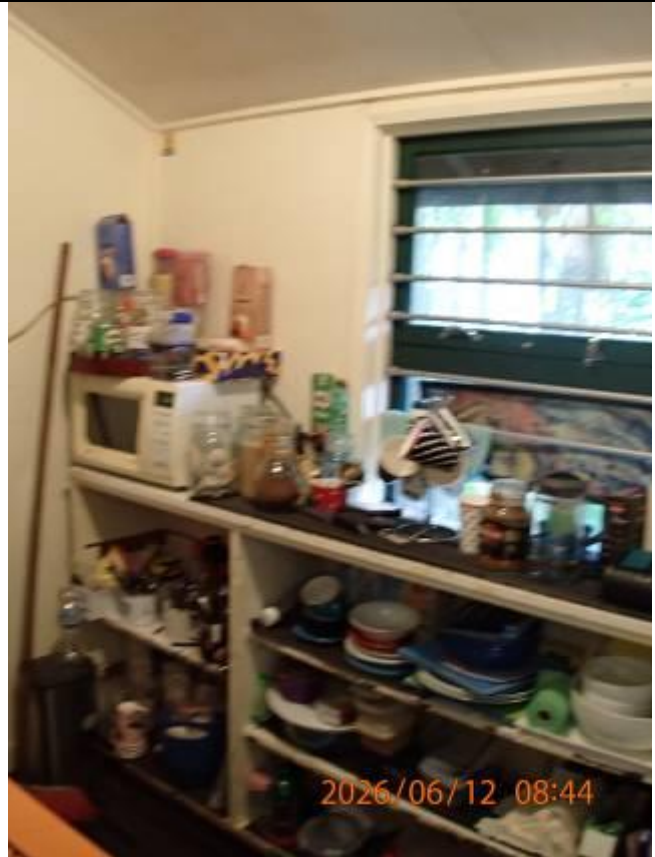
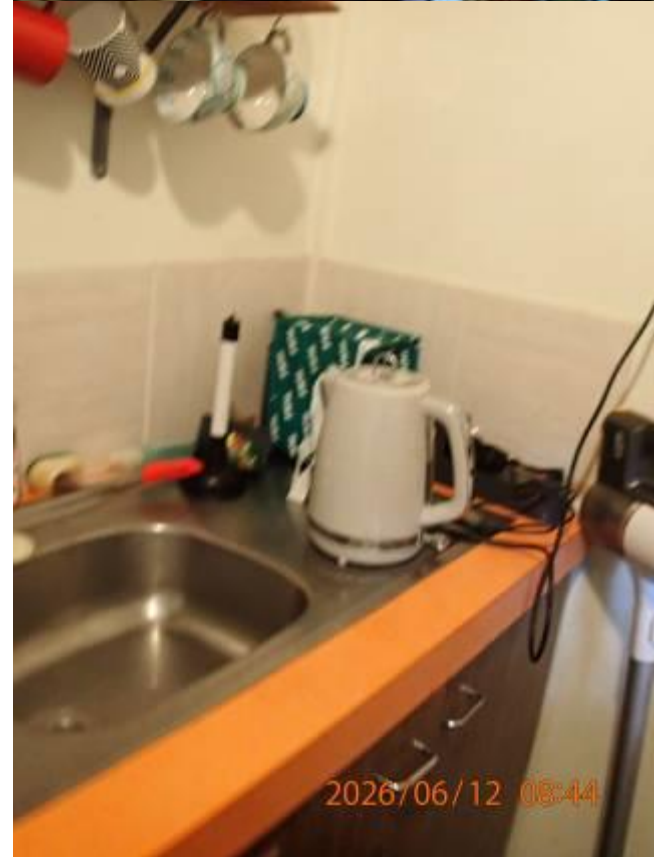
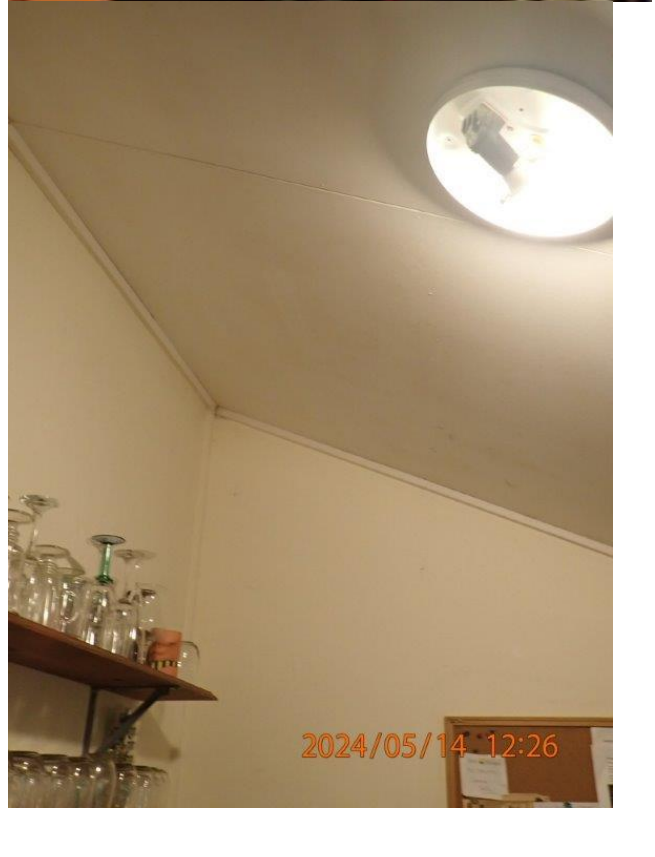
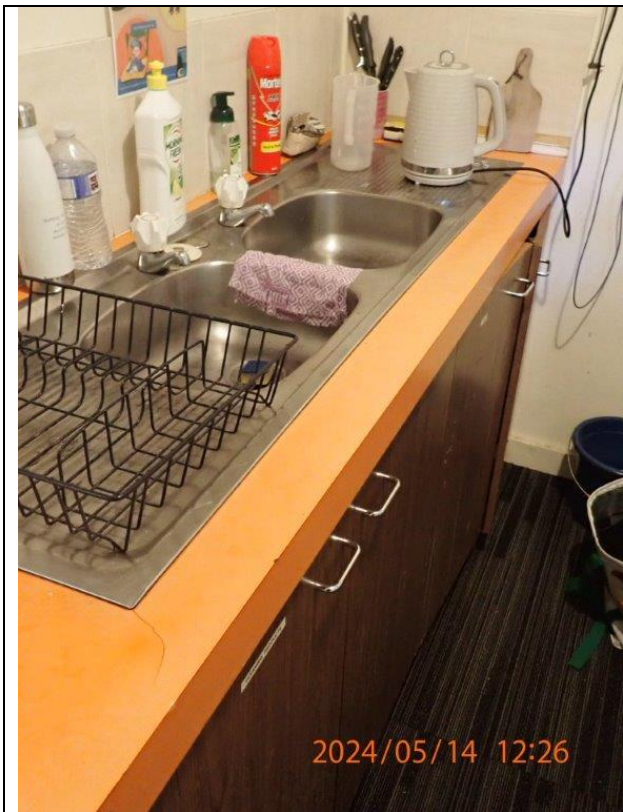
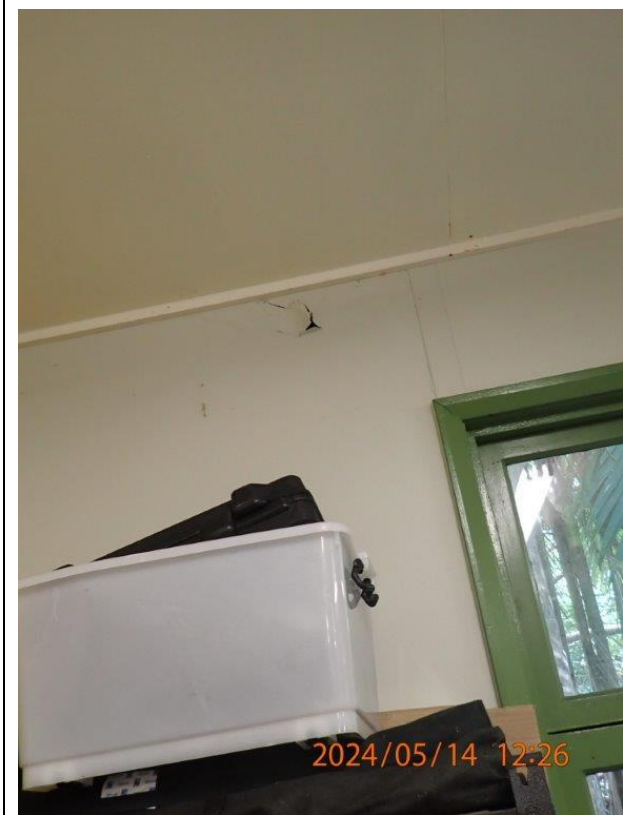
- Deterioration to bench tops. Hole in wall.
- Generally, appears to be in an acceptable condition.
- Recommend replacement of all sealants as preventative maintenance when required.
