Confidential Property Report

A.C.C.S. PROPERTY INSPECTIONS

Information Centre – Mission Beach

14/05/2024 and 12/6/2026

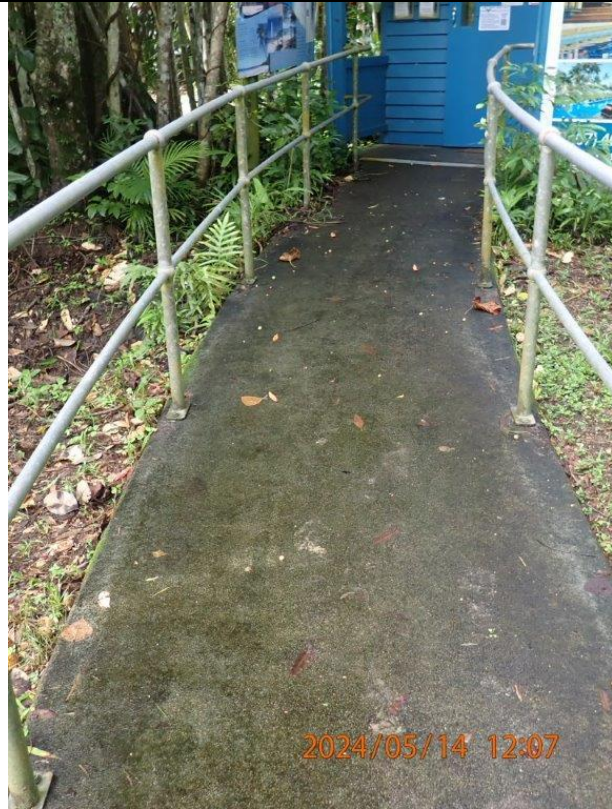
Allotment	Comments
<p data-bbox="115 268 316 304">Paths & Drive</p>   <p data-bbox="435 1052 706 1087">2026/06/13 08:40</p>	<ul data-bbox="836 275 1356 388" style="list-style-type: none">• Defect: Mould• Location: Throughout• Recommendation: Cleaning required   <p data-bbox="1091 1157 1362 1192">2026/06/13 08:40</p>

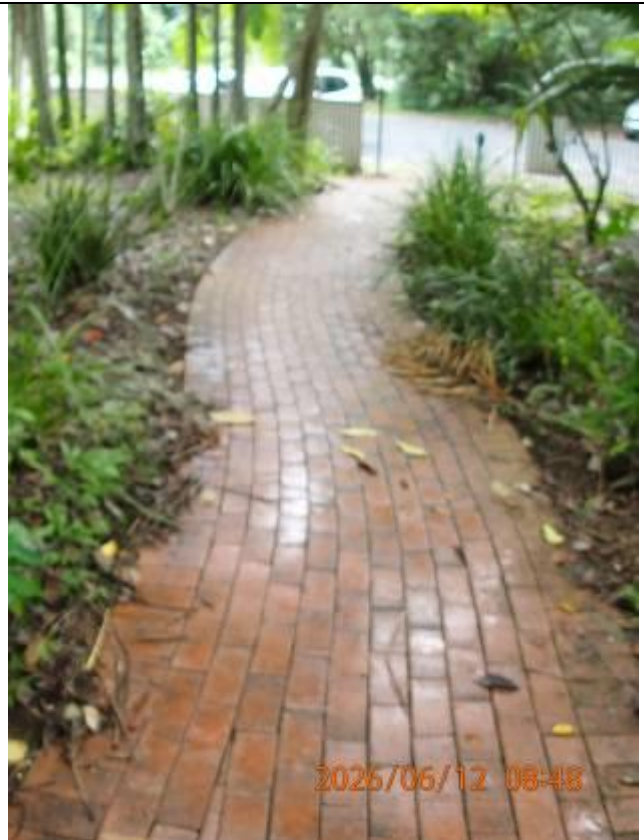
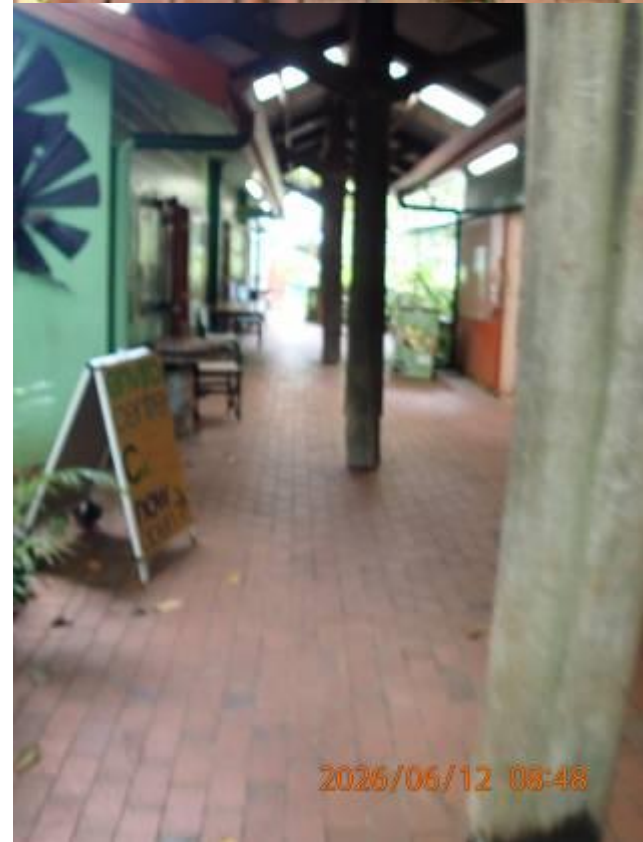
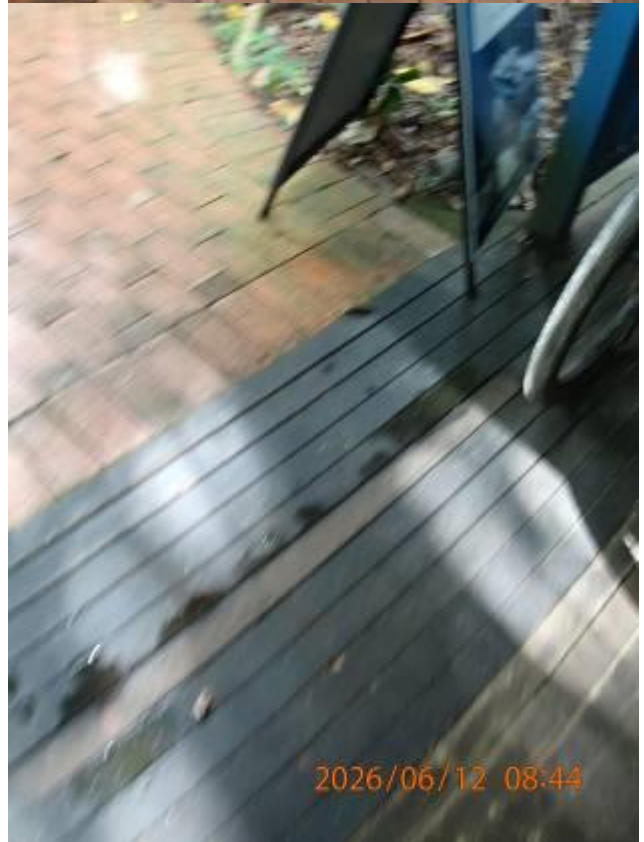
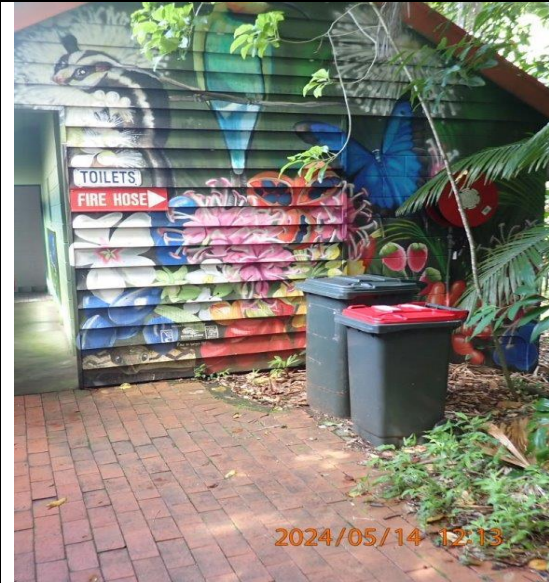
- Defect: uneven surface and mould
- Location: as pictured
- Recommendation: cleaning required

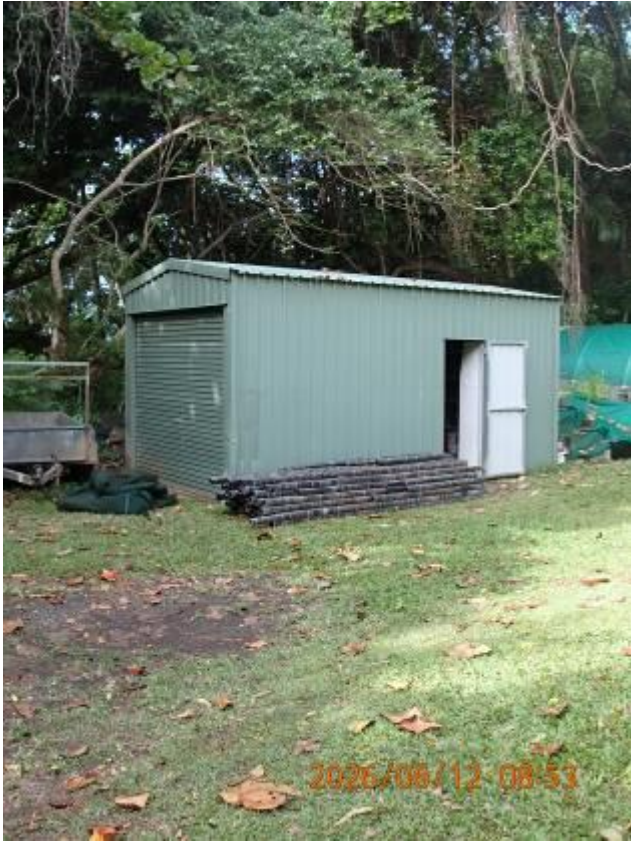
Shed

- cleaning of roof and walls required.

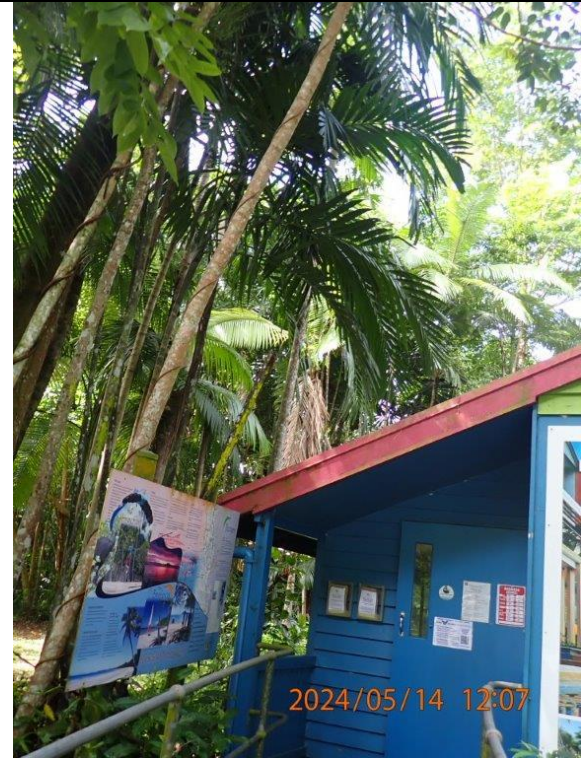
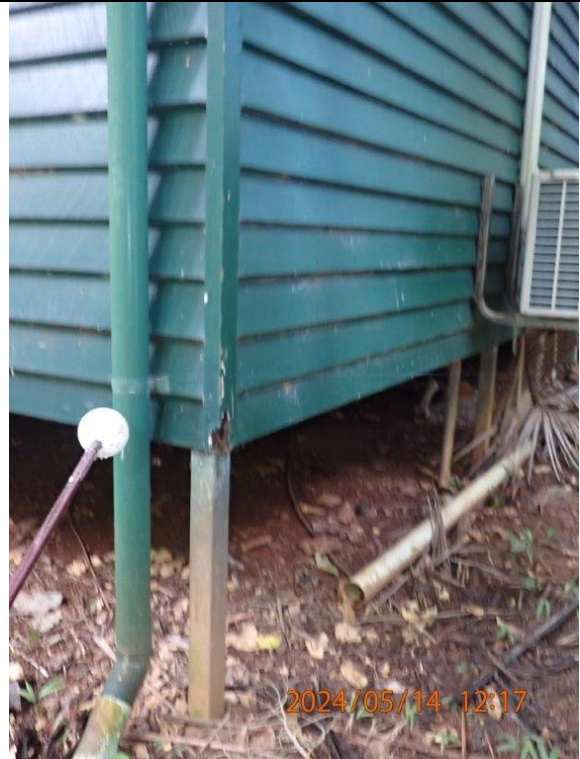
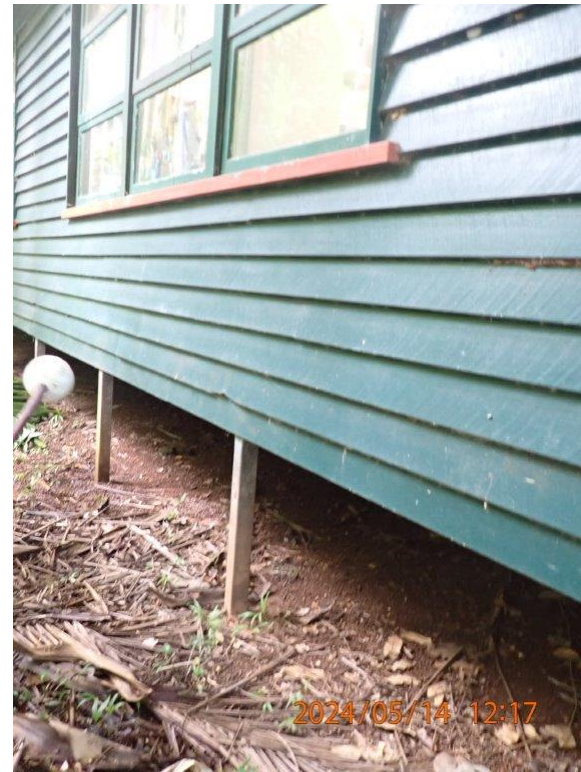
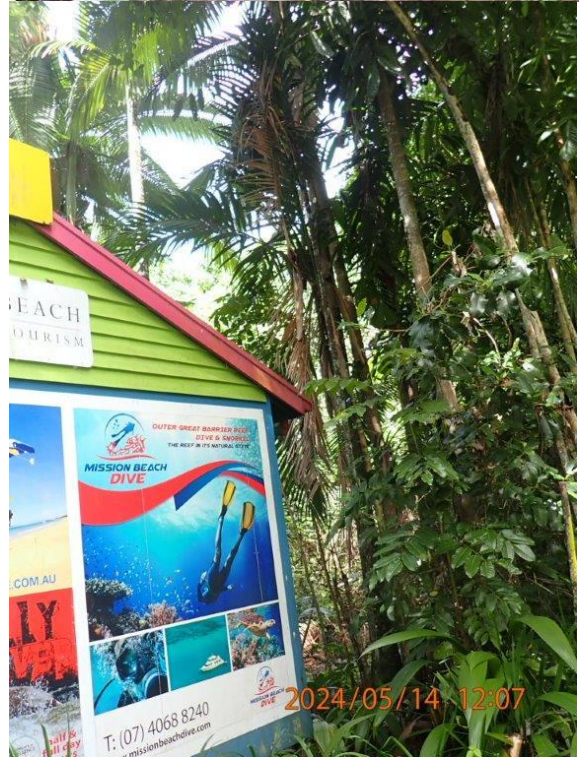
Building/House Exterior	Comments
External Walls and claddings	<ul style="list-style-type: none">• Defect: Timber rot present• Location: as pictured• Recommendation: Major remedial action required

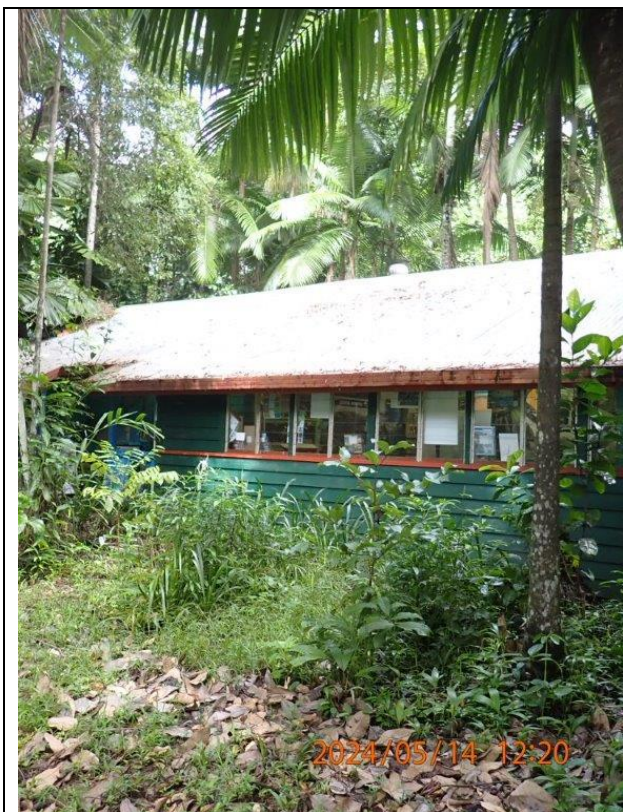
- Defect: Deterioration visible to all surfaces and fixings
- Location: throughout
- Recommendation: **Plumber** – Engage a suitably qualified plumber to provide rectification advice in accordance with AS/NZ 3500

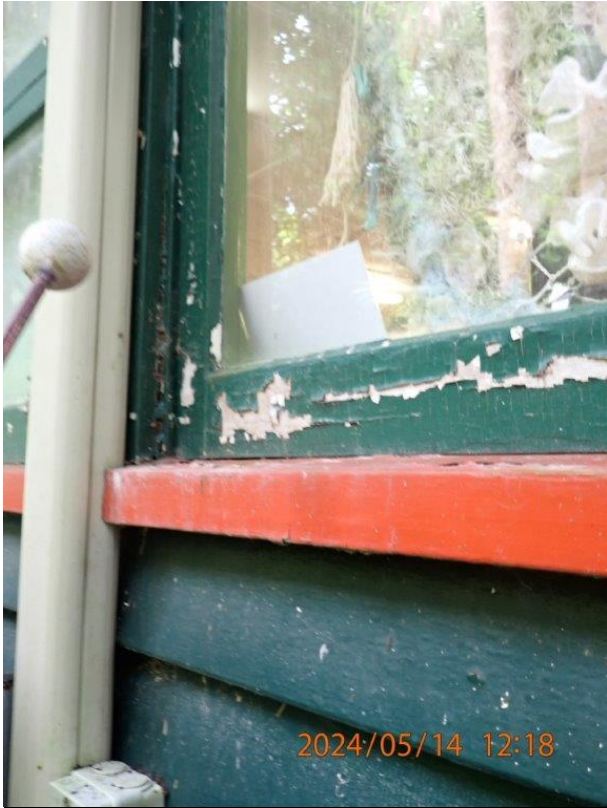
Painted Surfaces

- Deterioration visible to all painted surfaces

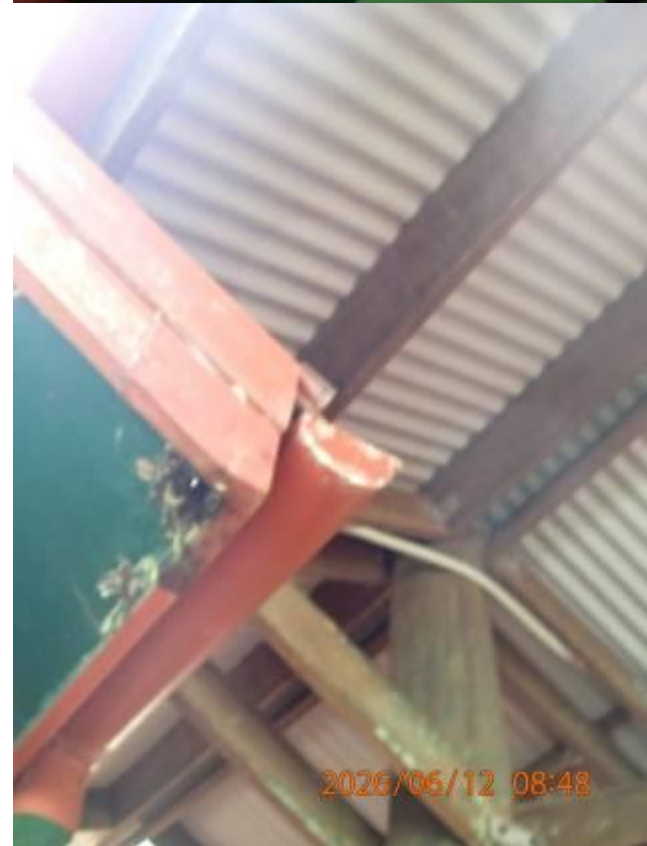
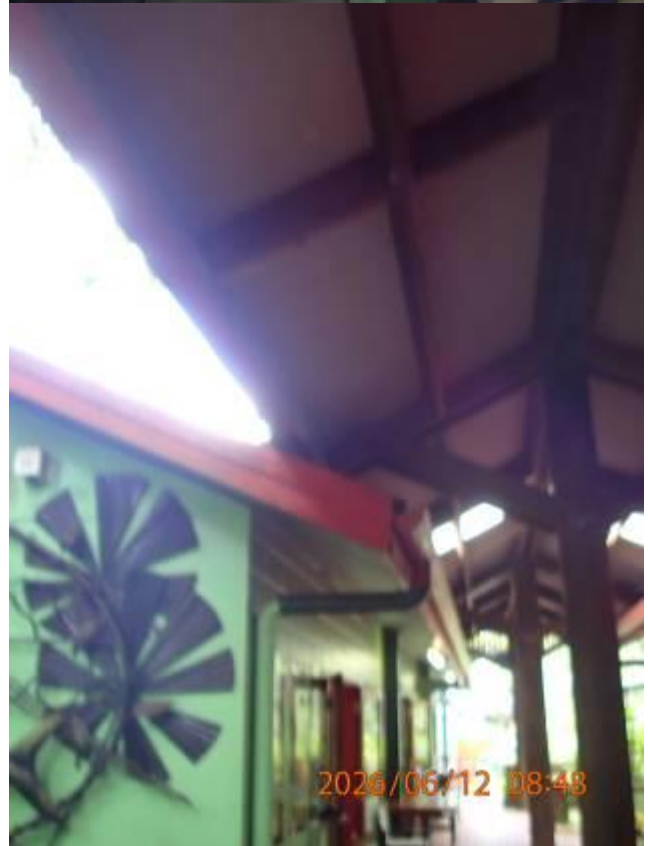
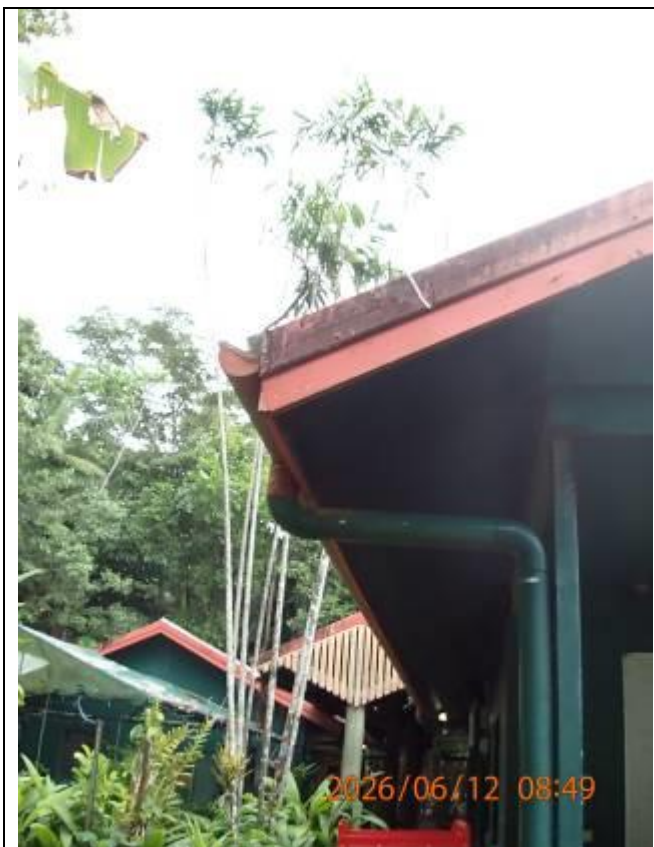
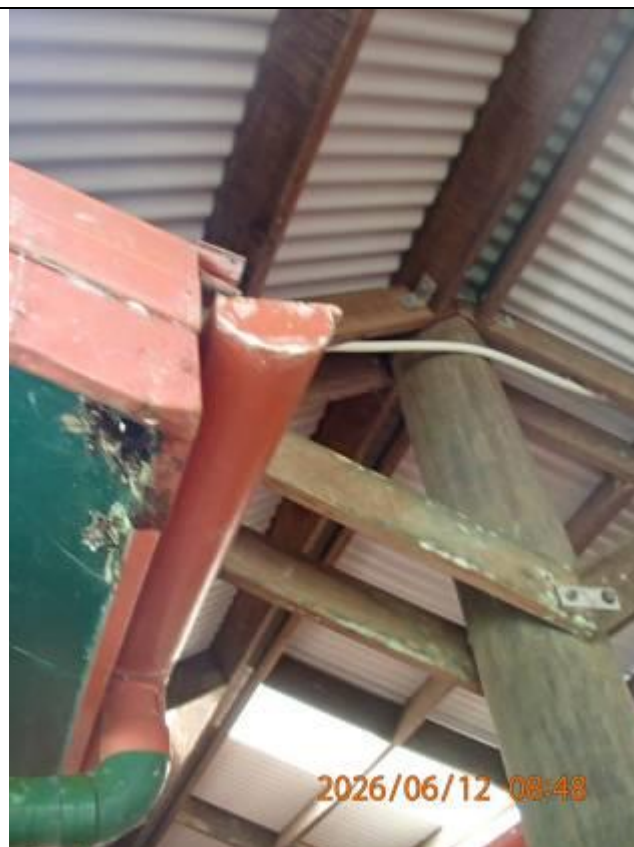
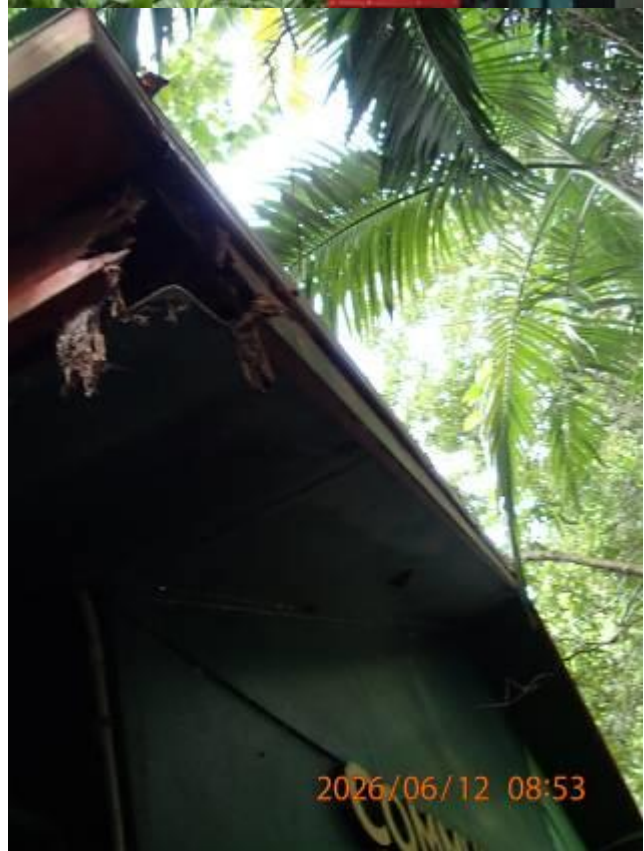
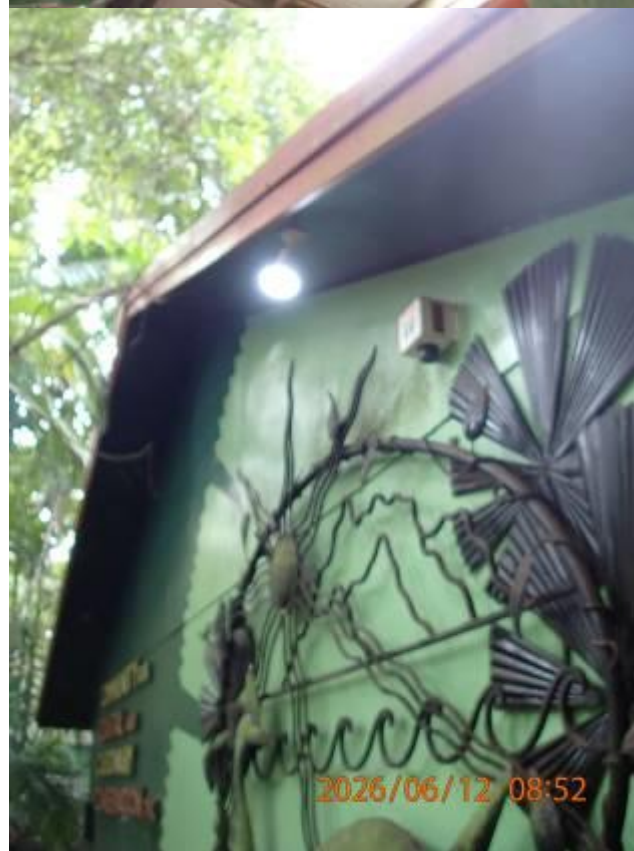
- Defect: movement of all sheeting is visible.
- Roof space is accessible to rodents.
- Recommendation: **Plumber** – Engage a suitably qualified plumber to provide rectification advice in accordance with AS/NZ 3500

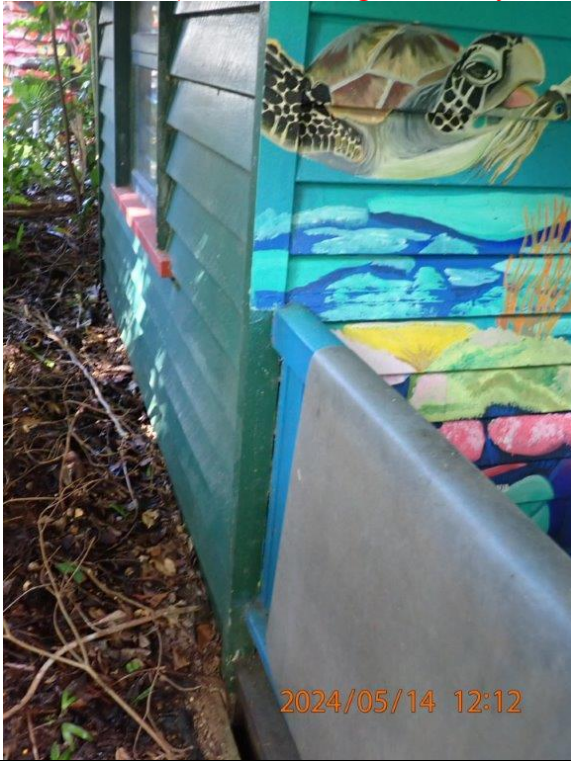
Foundations (Visual above ground only)

- Defect: foliage

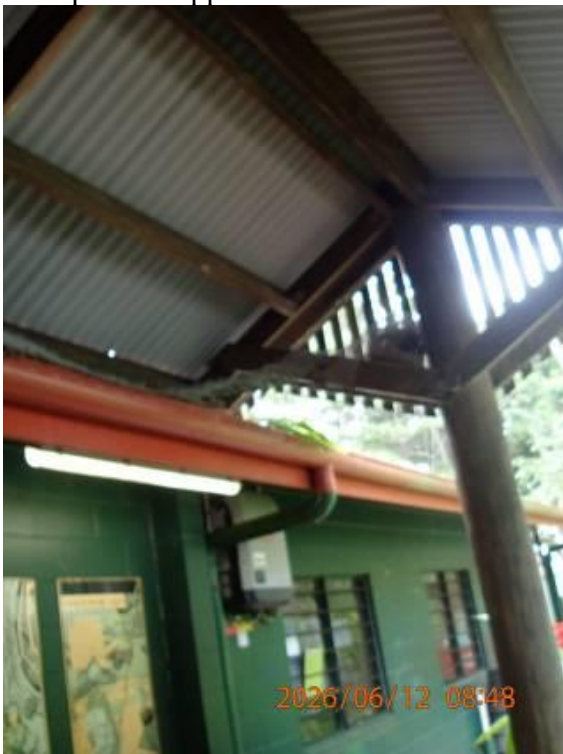
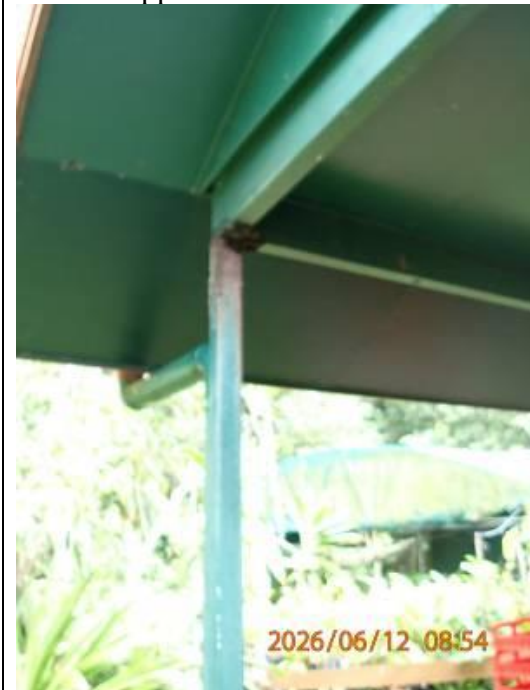
Stumps and supports

- Visible rust to base of several metal supports, repairs are required. Deterioration to timber supports.

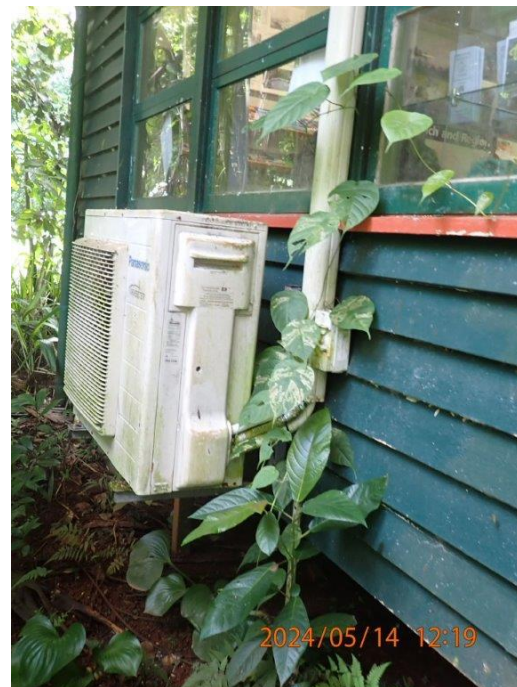
Air con

- Where installed generally appears to be in an acceptable condition with repairs required to frames.
- Recommend Air conditioner drainpipe to be diverted to prevent deterioration to foundations. Visible rust to ac frame
- Recommend Drainpipe to be plugged with a pot scourer to prevent vermin entering.

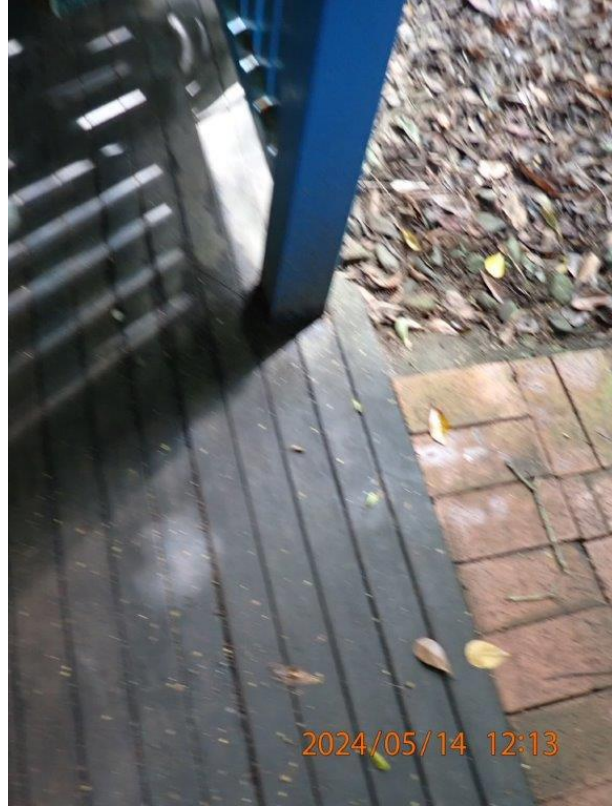
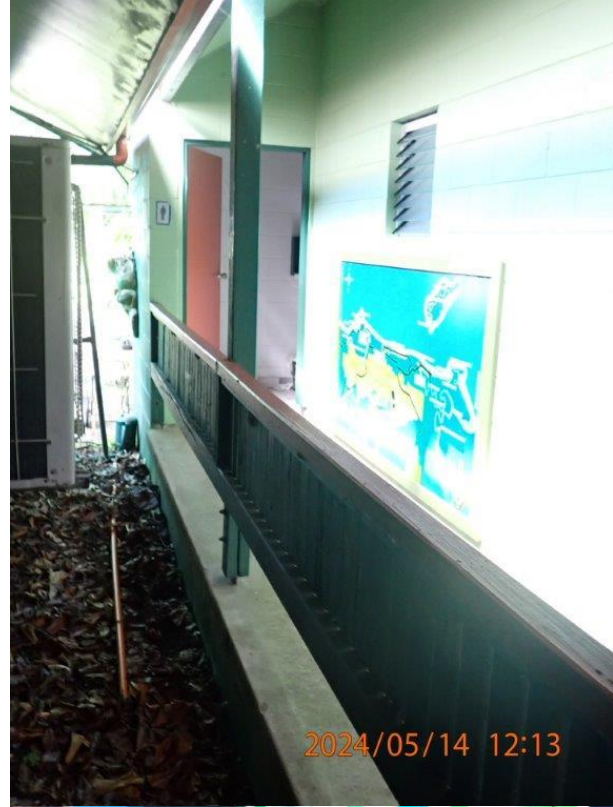
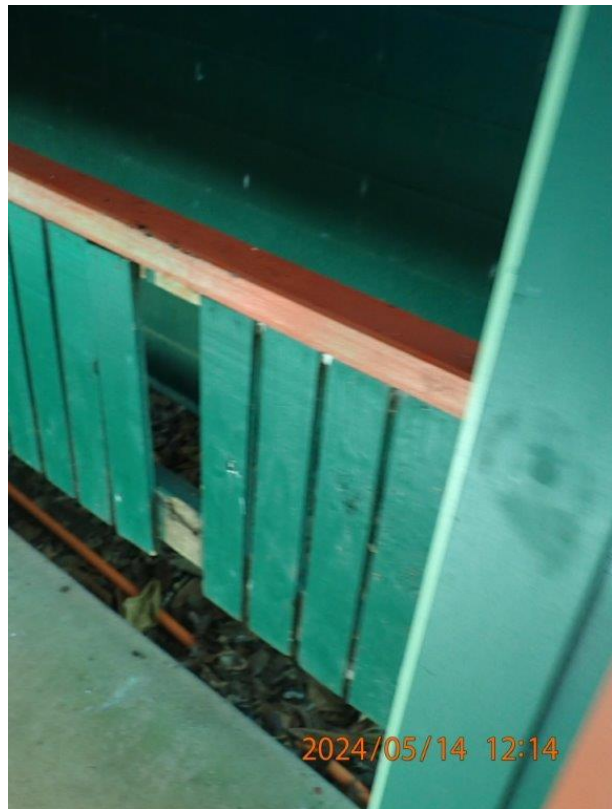
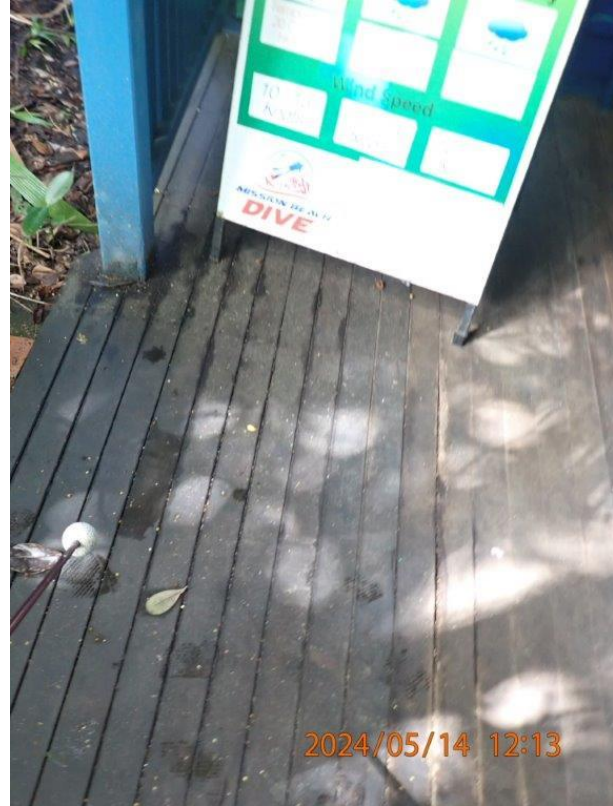
Stairs and verandah

- Timber rot present.
- timber deterioration visible to supports, balustrades, etc

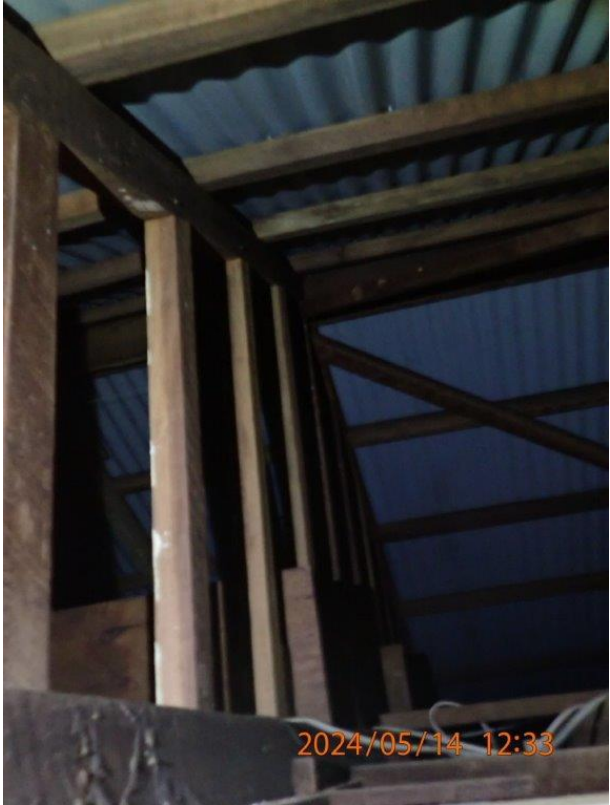
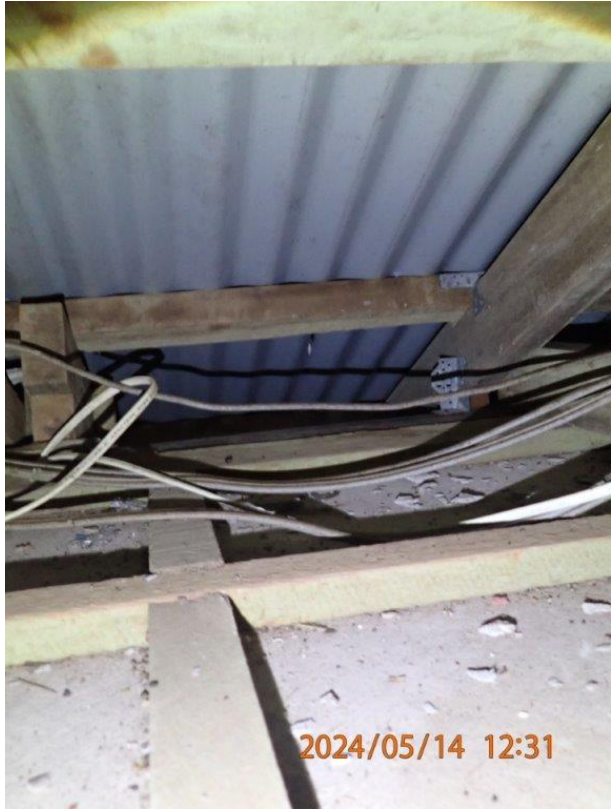
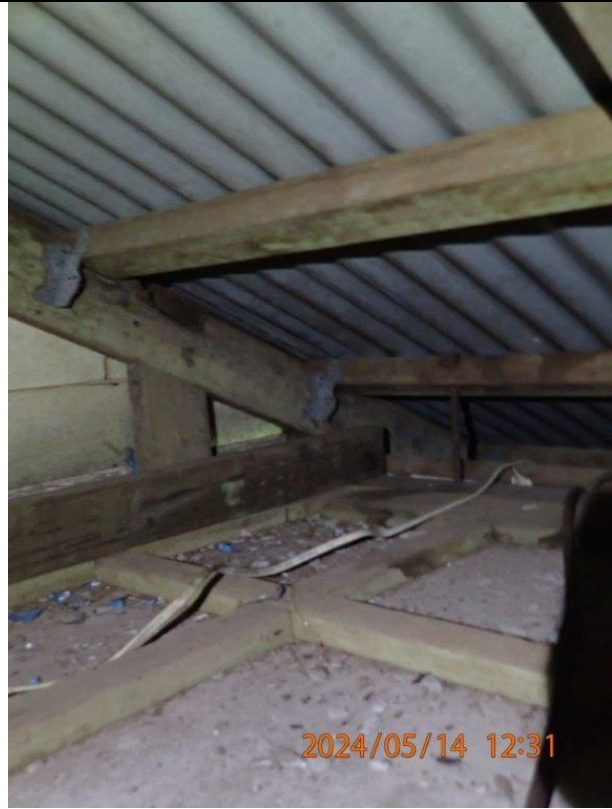
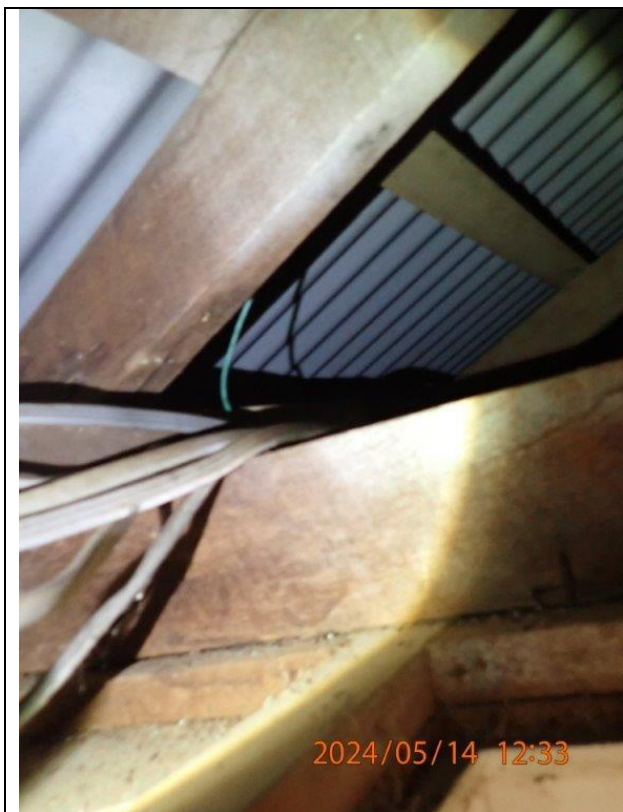
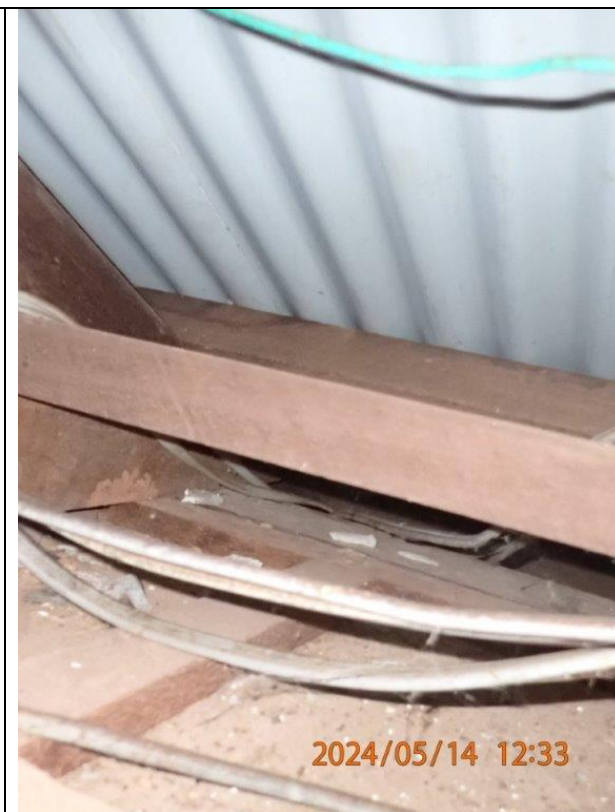
<ul style="list-style-type: none"> • Defect: minor deterioration • Recommendation: Carpenter – engage a suitably qualified carpenter for rectification advice in accordance with A1684.2

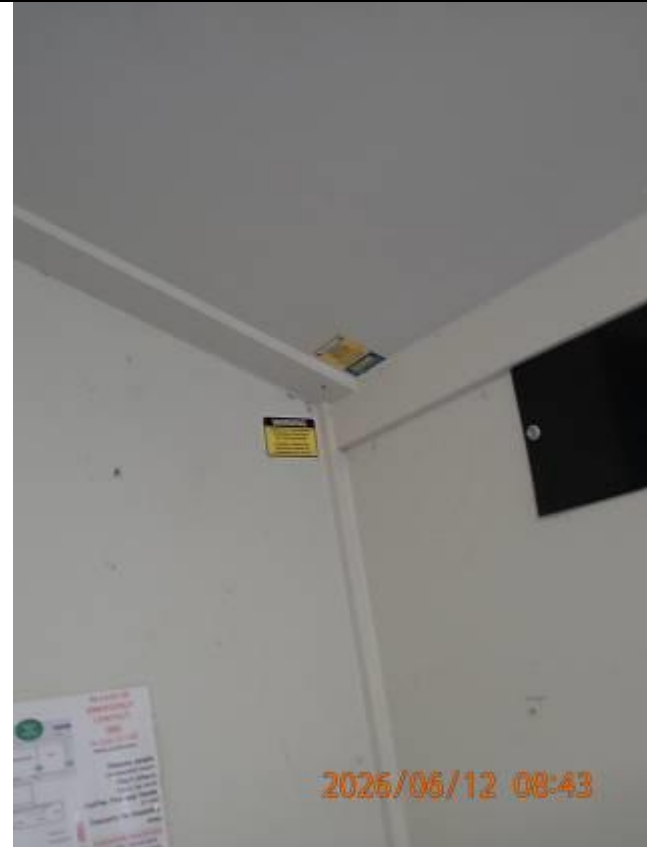
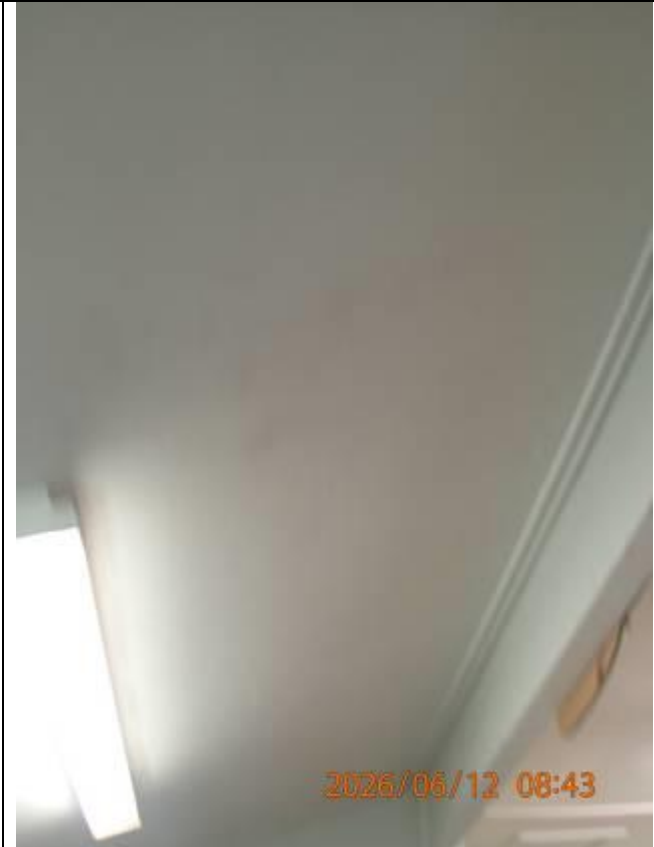
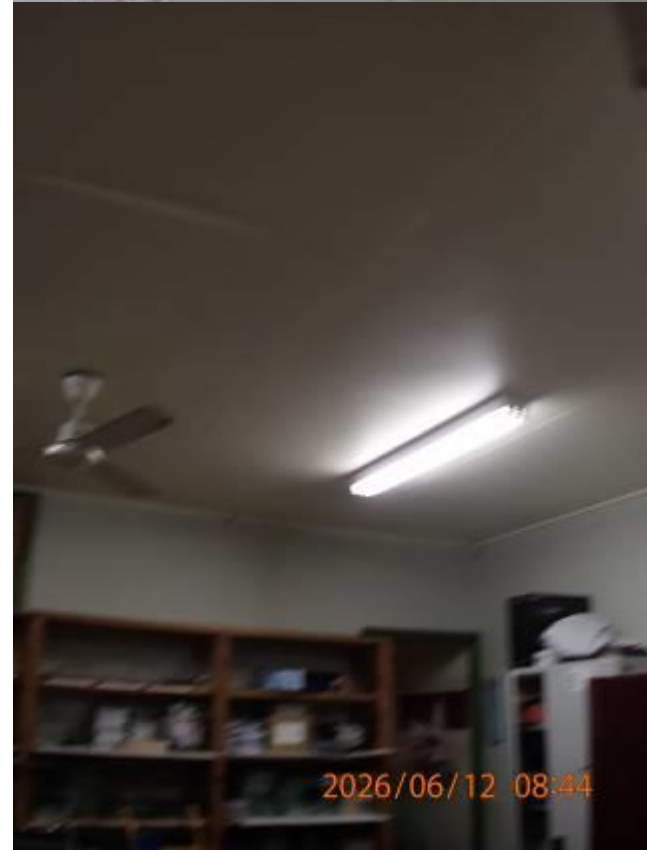
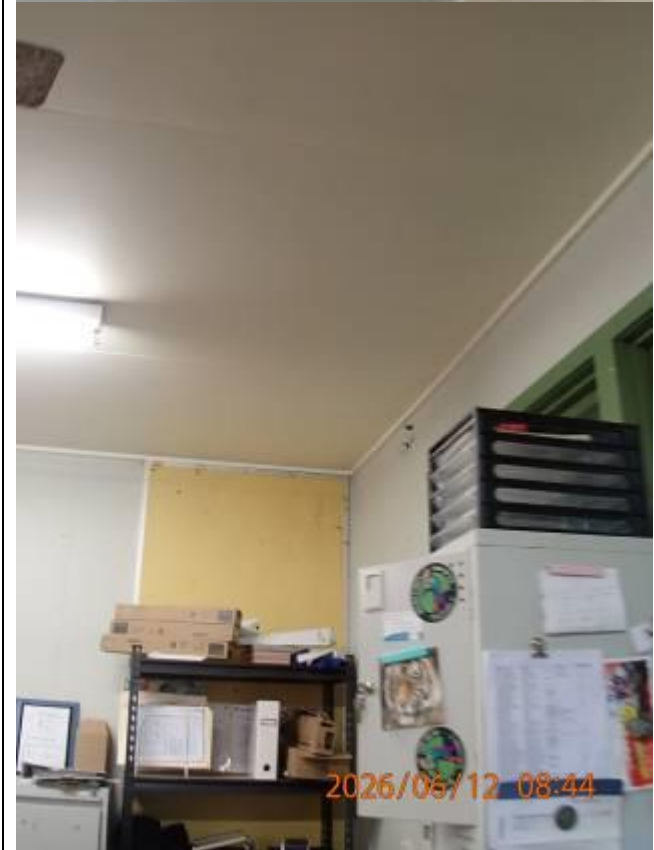
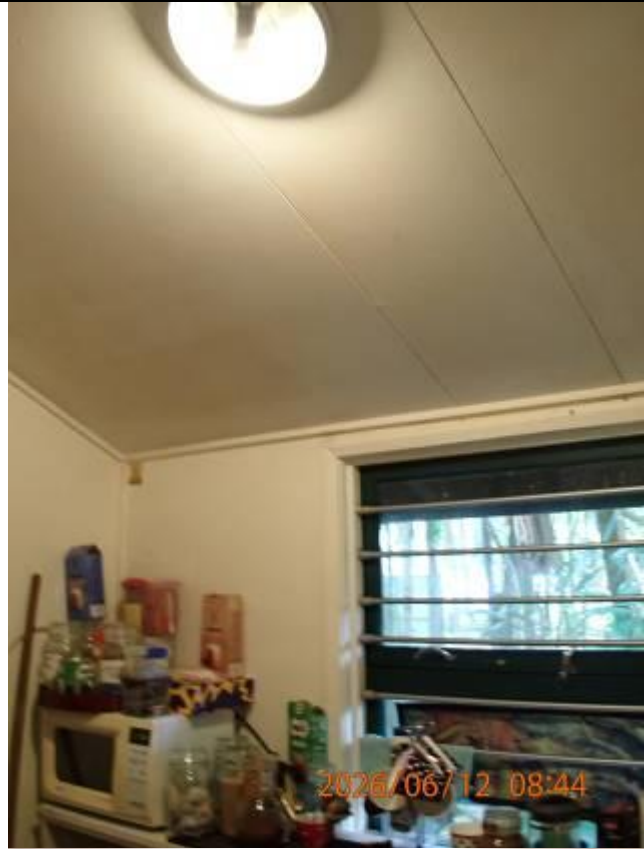
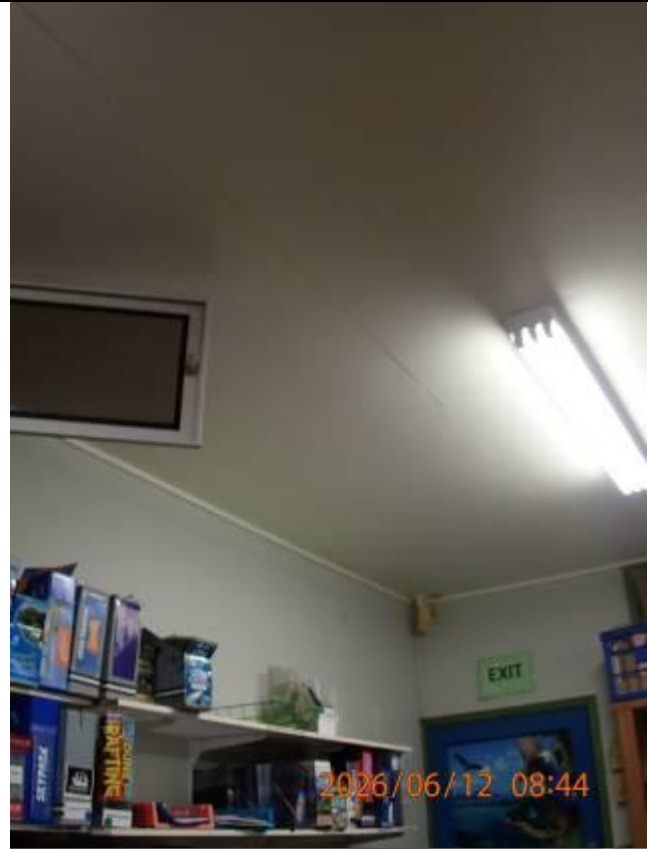
Ceiling lining

- Ceiling panels have sagged

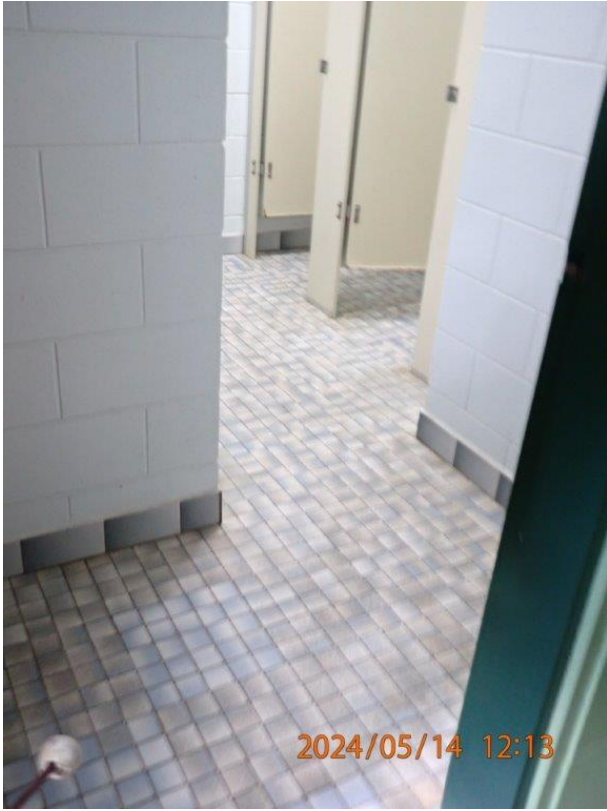
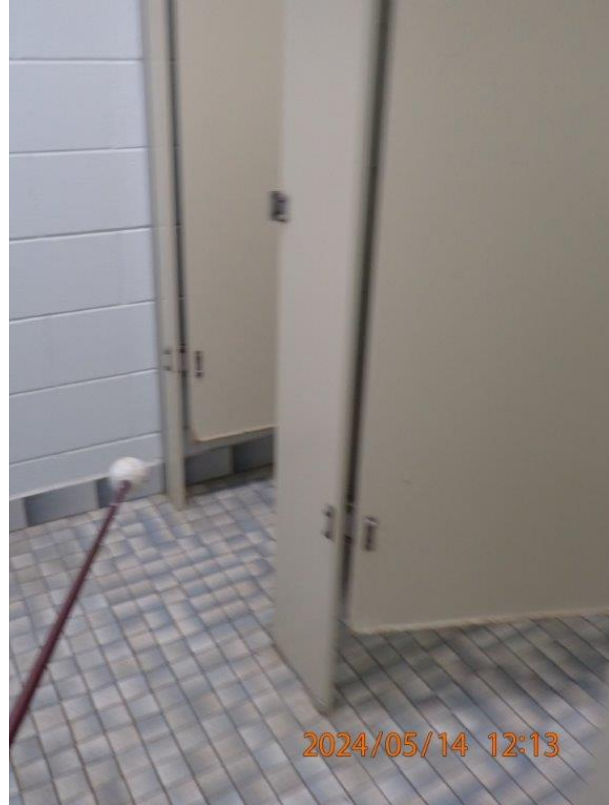
Bathroom 1 –

- Deterioration to doors
- Generally, appears to be in an acceptable condition.
- Recommend replacement of all sealants as preventative maintenance when required.

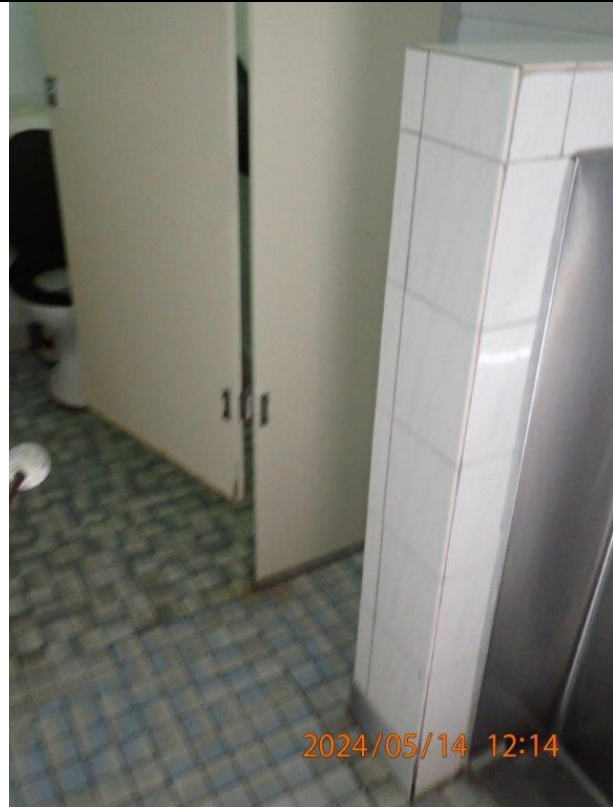
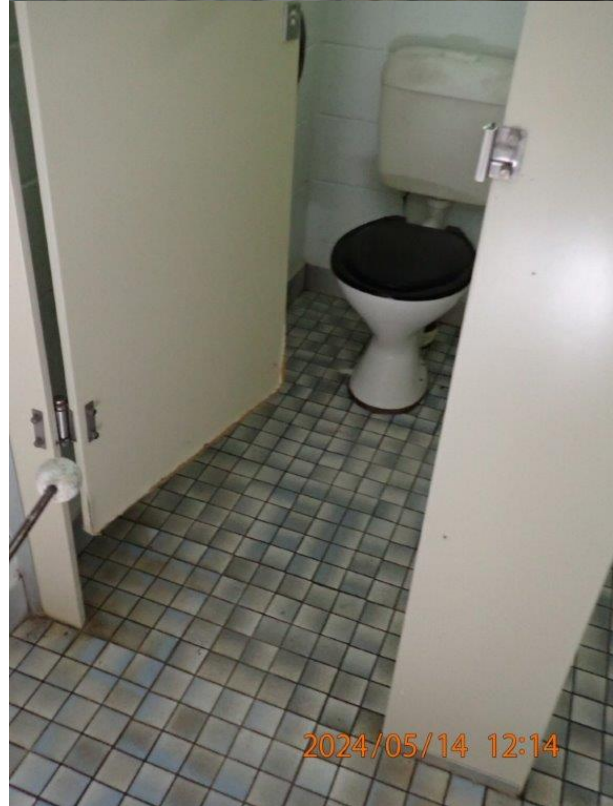
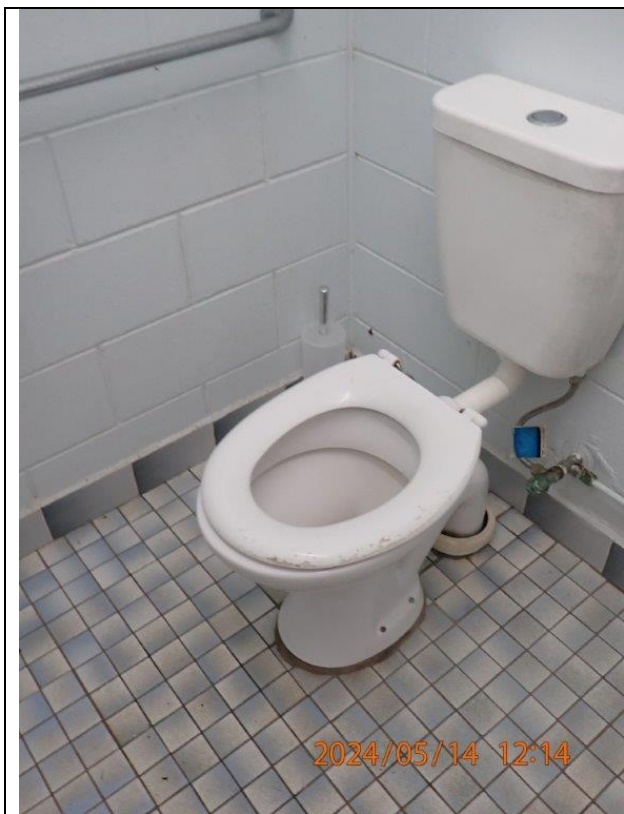
Bathroom 2 –

- Deterioration to doors
- Generally, appears to be in an acceptable condition.
- Recommend replacement of all sealants as preventative maintenance when required.
