**Registered Water Service
Provider No. SP478**

DRINKING WATER QUALITY MANAGEMENT PLAN

May 2021

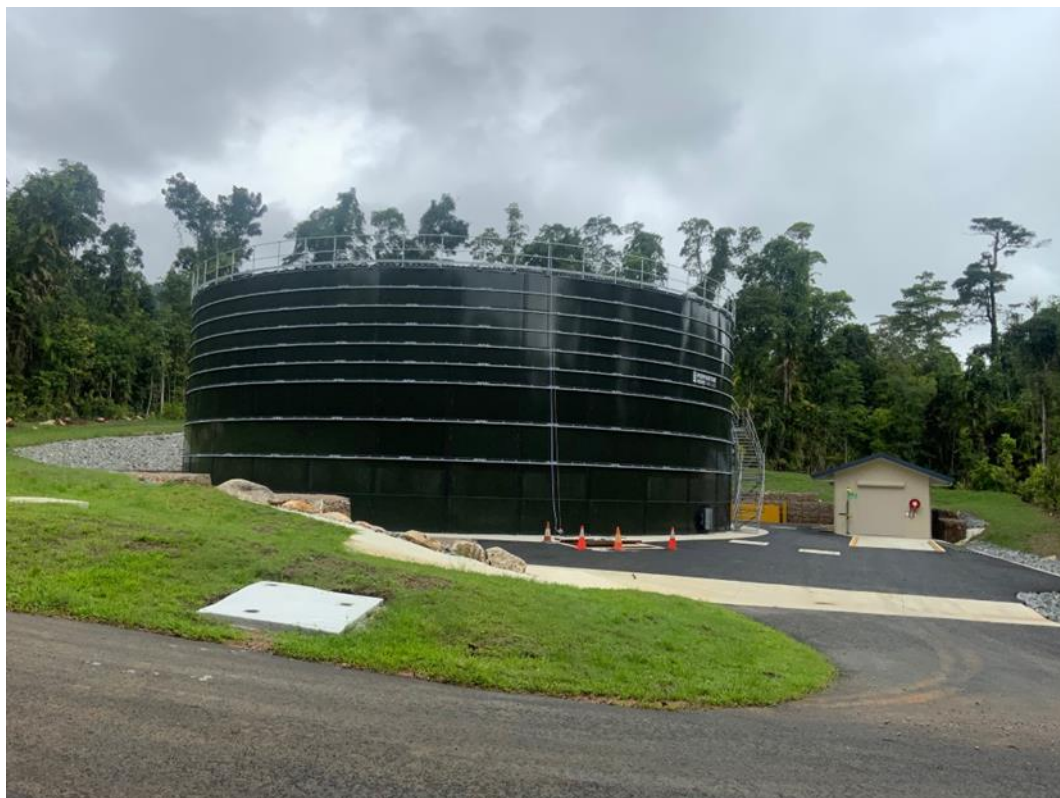
Figure 5.1: 4.5 MI Bulgun intake reservoir and Chlorine dosing building

In October 2020 Council completed the construction of 4.5ML reservoir just downstream of the Bulgun Creek intake. Intake flows are directed into the reservoir on a continuous basis unless the Bulgun Creek source water has turbidity above 5NTU. Turbidity analysis equipment has been installed upstream of the reservoir and when the turbidity exceeds 5NTU, the intake valve into the reservoir is automatically closed and only reopened when turbidity falls below 5NTU. The clear water storage in the new Bulgun intake reservoir and other reservoirs in the network are then able to supply clean water into the network. Photos of the completed reservoir, the SCADA arrangement and the automated valves are shown in Figures 5.1 to 5.3.

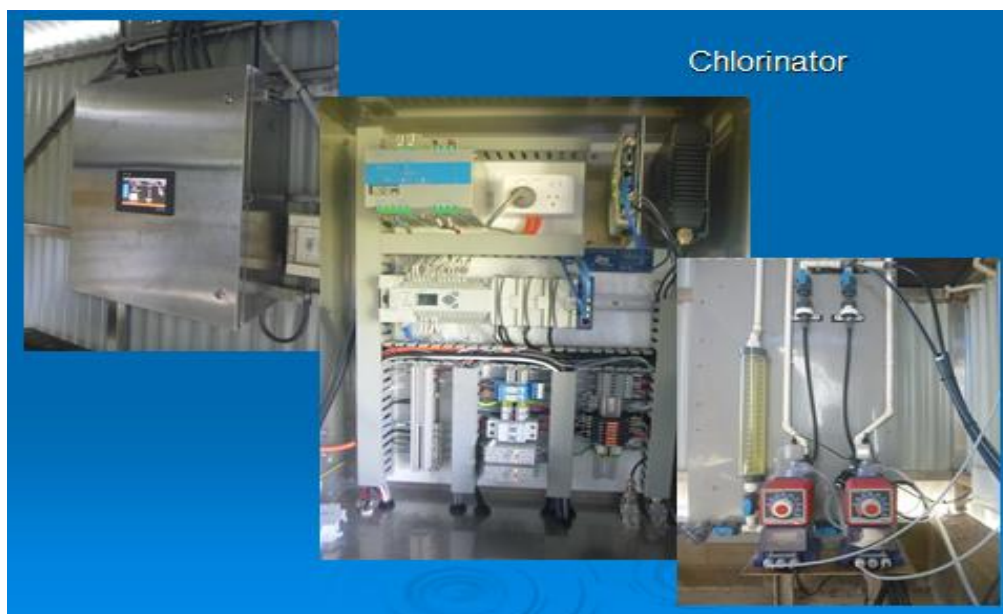
Figure 5.6: Facilities at the Bulgun Ck Chlorinator - SCADA and dual dosing pumps.

This site is some 2.5km downstream of the intake reservoir and is the original Bulgun chlorine dosing point. Following the commissioning of the intake reservoir dosing facility, this dosing site will be converted to a secondary dosing facility. Chlorine levels in the trunk main from the reservoir will be monitored and sodium hypochlorite (NaOCl) is injected as needed to maintain total chlorine levels at about 2.5 mg/L. Dosing is automatically flow paced by the PLC using inputs from the turbidity analyser and flow meter. In periods of high turbidity, dosing can also be increased remotely through SCADA. The site is inspected twice a week or if an alarm is triggered through the SCADA. The site has mains power and an emergency generator. The facilities at this site are shown in Figures 5.6 and 5.7.

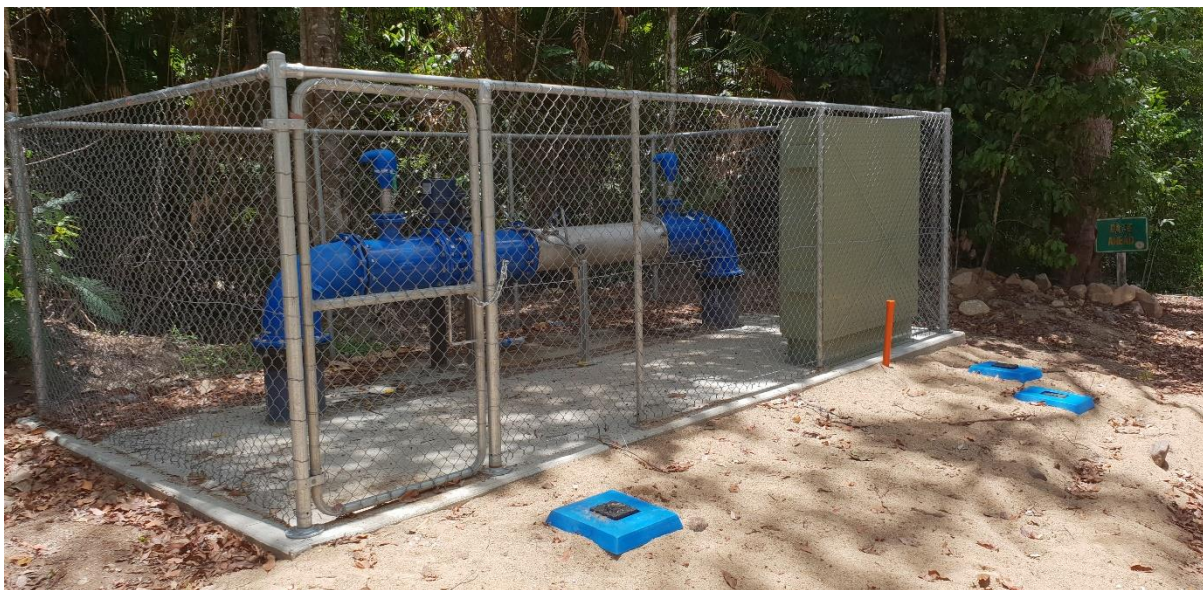
Figure 6.1: Meunga Autoscour

Located 1km downstream of the intake is the Meunga Creek Autoscour. The autoscour consist of two motorised valves (main line and scour), a turbidity analyser and a SCADA system with radio telemetry. The autoscour allows the treatment operators to remotely monitor the turbidity in the source water close to the intake and automatically change over to the supplementary supply at Kennedy Bore if required.

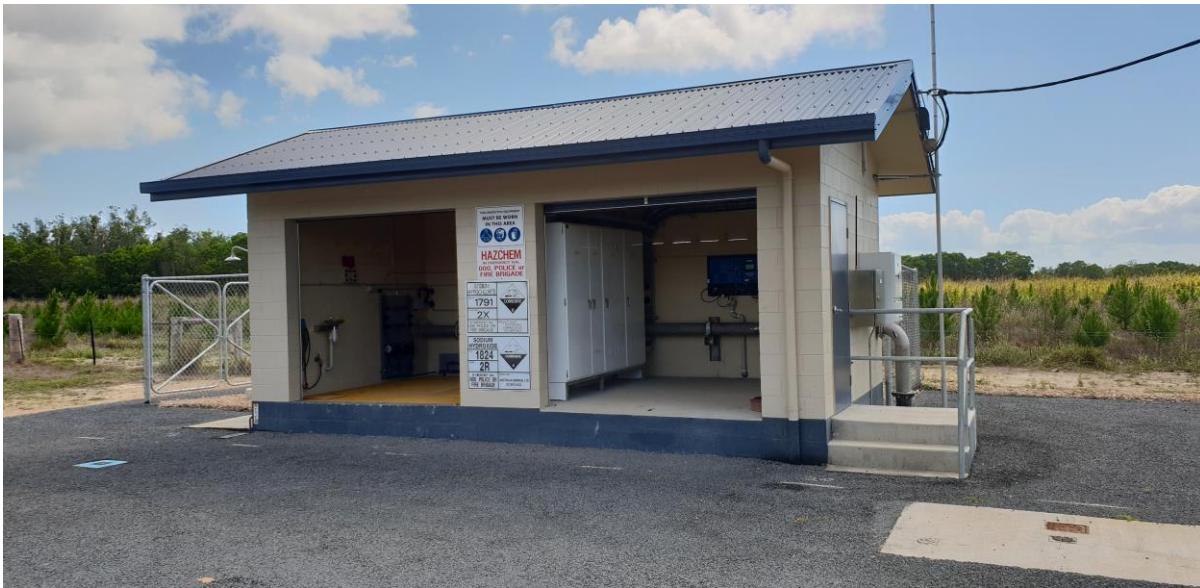
Figure 6.2: Kennedy Bore - Chlorinator

Kennedy Bore consists of a single submersible bore pump and a block building housing a disinfection system and SCADA system.

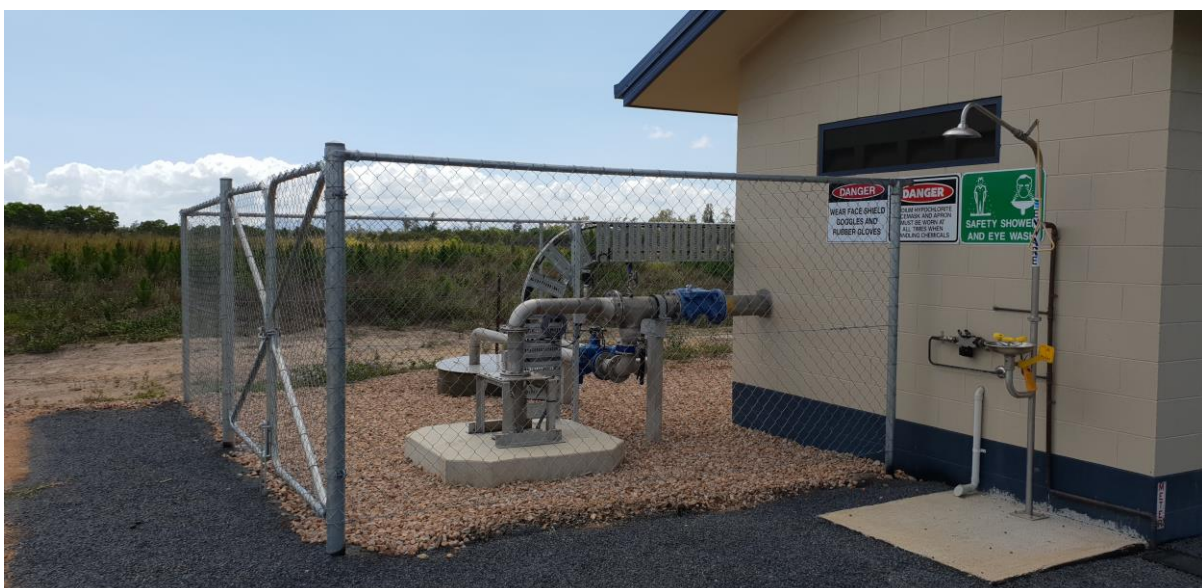
Figure 6.3: Kennedy Bore

Water is sourced from the bore using a submersible bore pump and pumped into the reticulation main at Ellerbeck Road. The control of the pump is via a variable speed drive (VSD) that is programed to provide a constant pressure (6 Bar) at the point of discharge while maintaining the required flow demand to the network. The pump station is connected to mains power or alternatively via a portable Generator. The bore head is above the Q100 flood elevation, concrete capped and sealed in good condition.

During turbid water events in Meunga Creek, monitored at Meunga Autoscour, the source water for Cardwell Water Supply Scheme can be automatically changed over to Kennedy Bore and maintain supply. The bore can supply the complete demand for the Cardwell system until the Meunga Ck source water clears which is usually within three (3) days.
