ASBESTOS MANAGEMENT PLAN

Prepared for Cassowary Coast Regional
Council

Information Centre
55 Porter Promenade
Mission Beach QLD

AMP 707-19

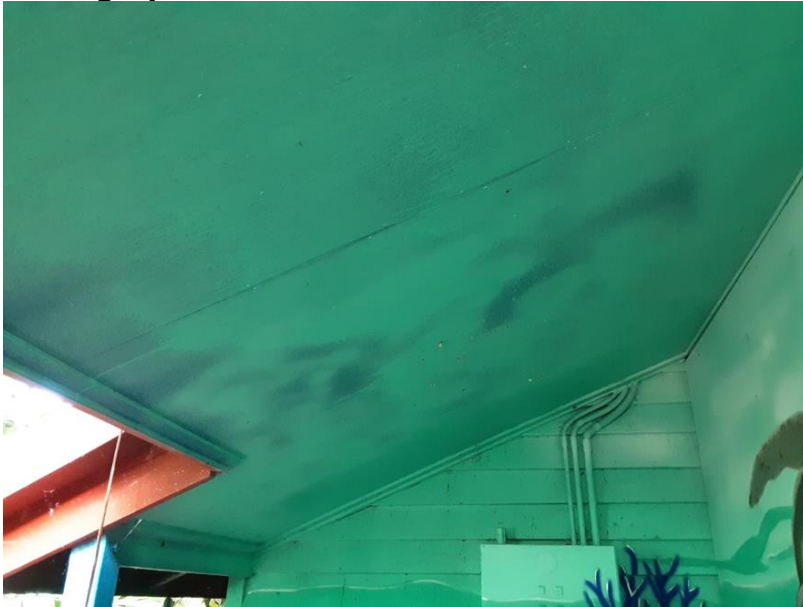
Location 1: Sheeting to the verandah ceilings
Photograph 1

Location	Type	Condition	Health risks	Photo No.
Sheeting to the verandah ceilings	Presumed	Good	Low	1
Sheeting to the walls and ceilings throughout	Presumed	Good	Low	2 & 3

Location	Sample Number	Type	Friable Bonded	Condition	Priority	Photo No.
Sheeting to the verandah ceilings		Presumed	Bonded	Good	Low	1
Sheeting to the walls and ceilings throughout		Presumed	Bonded	Good	Low	2 & 3

- Avoid damage and abrasion of product;
- All areas should be kept well painted;
- Monitor condition of product and should significant damage or deterioration occur, then the product is to be removed in accordance with the relevant codes of practice and guidelines. A non-asbestos product is to be used as replacement material;
- Cutting, drilling and any other dust generating work should be avoided.
- Where it is necessary, dust suppression devices, measures to isolate the product and working area and personal protective equipment must be used.
- You must comply with all relevant State and Federal Legislation when working with asbestos.
- Asbestos Cement products that require extensive maintenance work should be removed and replaced with a non-asbestos product.
- A warning sign or label should be displayed
